# **Coastal Apartment Homes Project and Coastal Senior / Assisted Living Project**

*Final*  
**Initial Study/  
Mitigated Negative  
Declaration**

**August 2015**

**Rincon Consultants, Inc.**  
180 Ashwood Ave.  
Ventura, California 93003

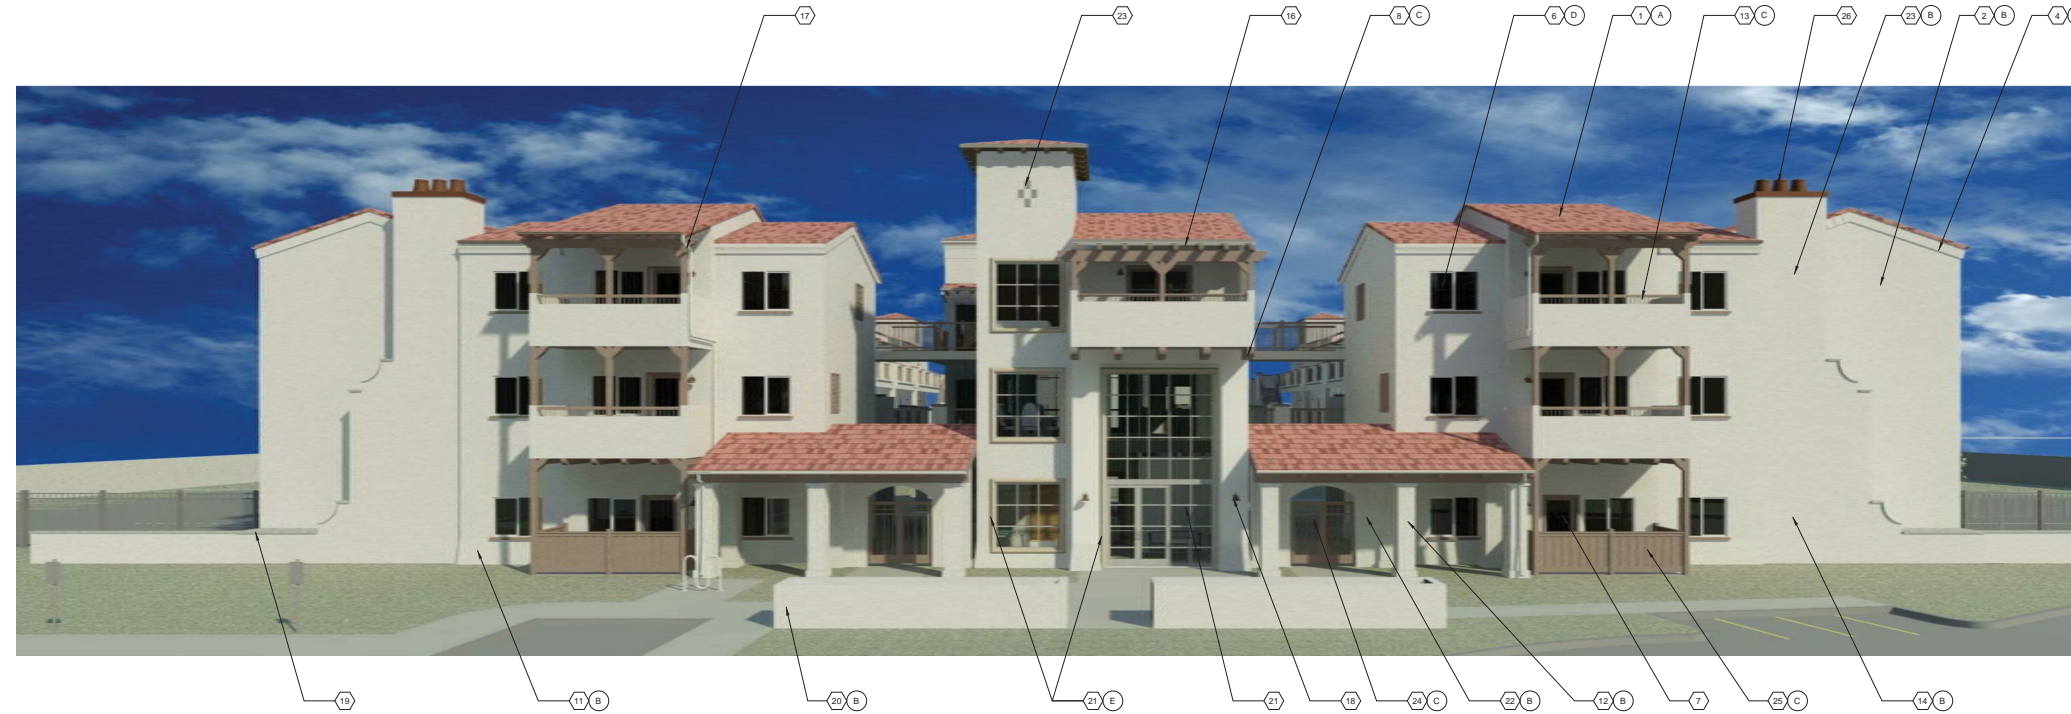
② NORTH ELEVATION - PLEASANT VALLEY ROAD  
NOT TO SCALE

- ① CONCRETE 'S' TILE ROOF: MORNING ROSE BARCELONA BY BORAL
- ② LIGHT SAND STUCCO FIELD WALL FINISH: DEW380 'WHITE' BY DUNN-EDWARDS PAINTS
- ③ ACCENT TRIM FINISH: DEAT159 'RICH MOCHA' BY DUNN-EDWARDS PAINTS
- ④ WINDOWS: DUAL GLAZED LOW 'E' CLEAR GLASS IN WHITE VINYL FRAMES
- ⑤ FOAM BAND WITH PLASTER FINISH: DE6173 'OAK HARBOR' BY DUNN-EDWARDS PAINTS

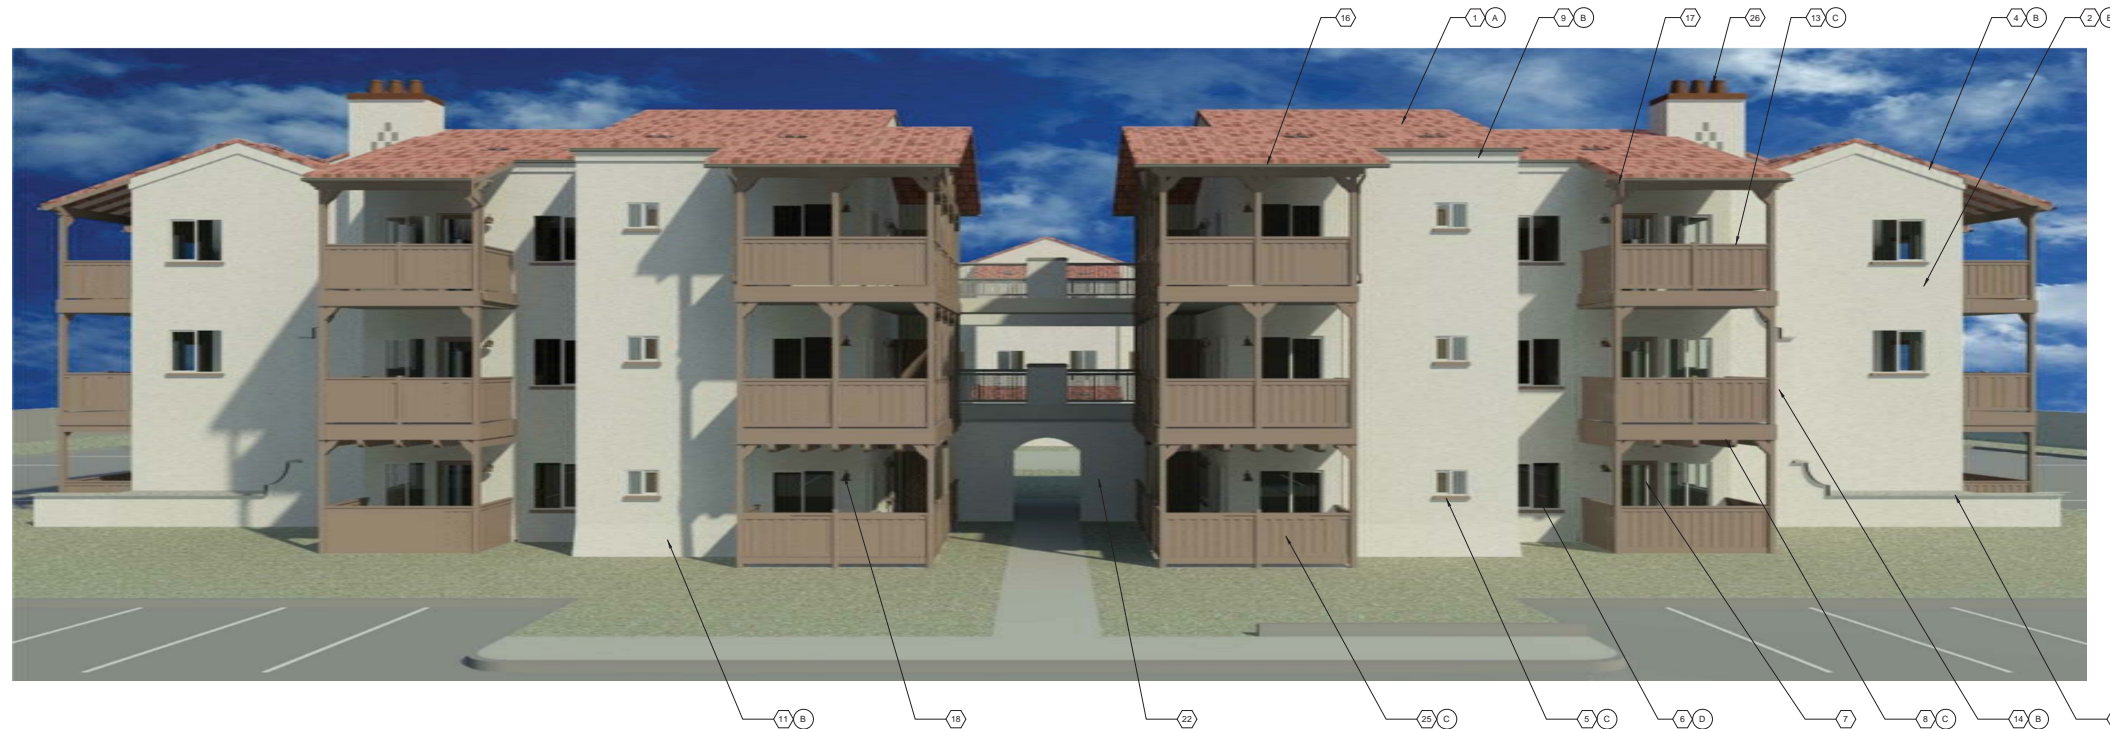
① SOUTH ELEVATION - PLEASANT VALLEY ROAD  
NOT TO SCALE

Elevations of Apartments

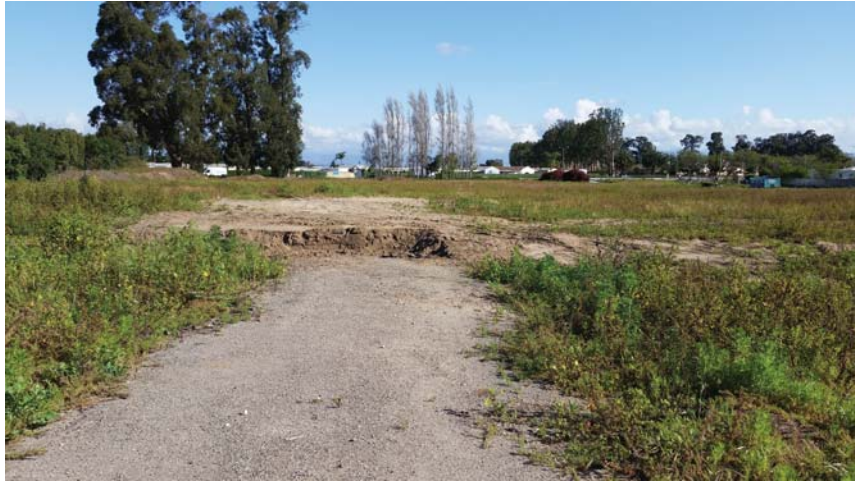
**Photo 1:** View of project site looking north from Etting Rd.

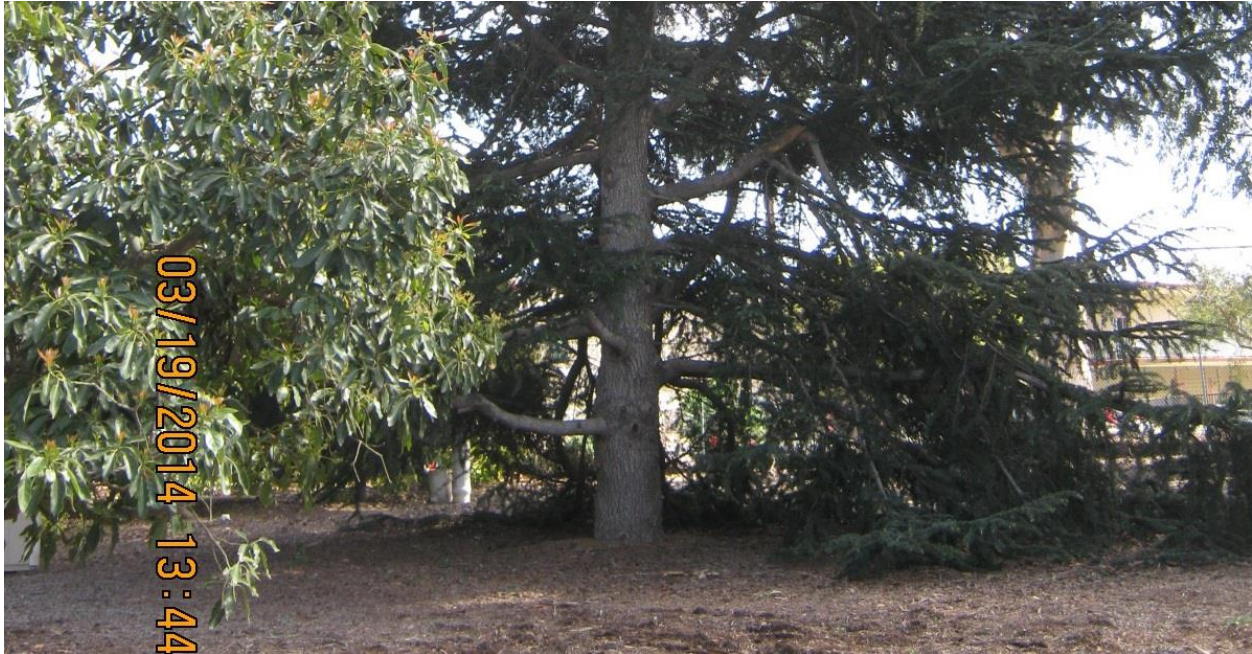
In this picture you can see the compacted farm road and large fruit stand in the critical rootzone. You can make out the many branch scars, topped branches, and dead hanging branches.

***3. Tree protection notes for remaining trees are limited. Arborist to add tree protection requirements with specific measures to protect the canopy of the trees as well as root systems where applicable. (Such as fencing at critical root zone and hand pruning for roots greater than a designated caliper).***

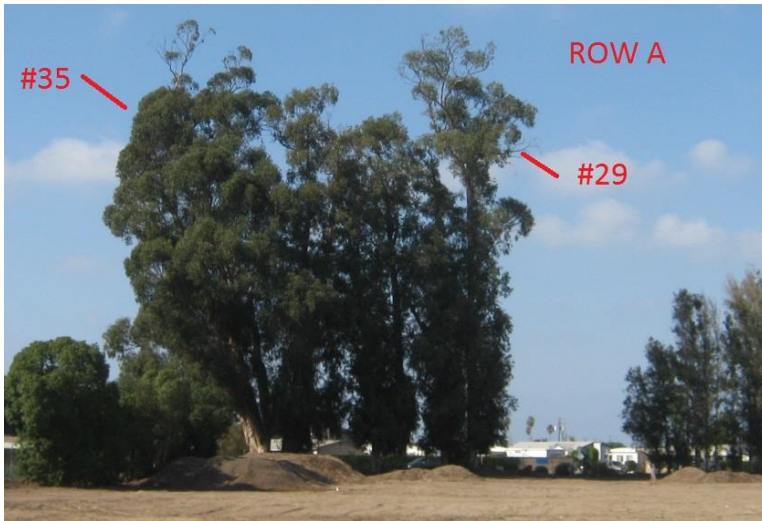
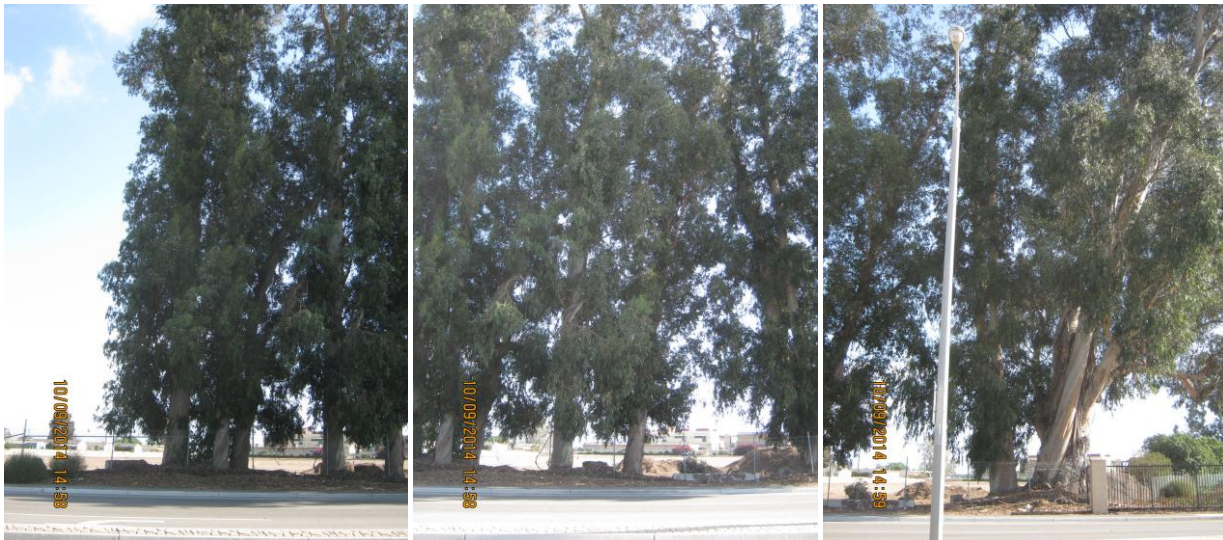
Row A

For risk assessment, I considered the trees both as individuals and as groups. I designated the group along Pleasant Valley Road as Row A. It includes 7 trees: 29 through 35.

Above looking north

Above panorama looking south L to R: 29 through 35

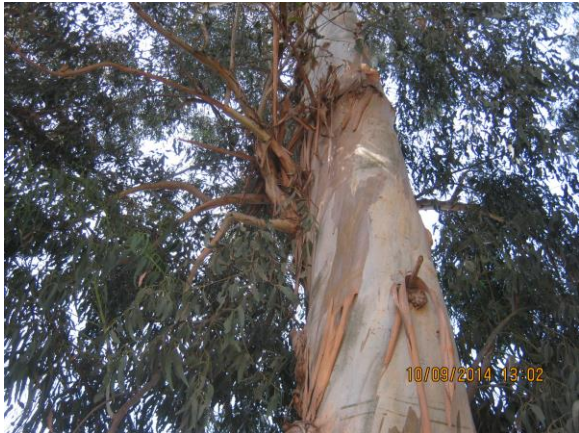
Small twisted branch clusters, typical

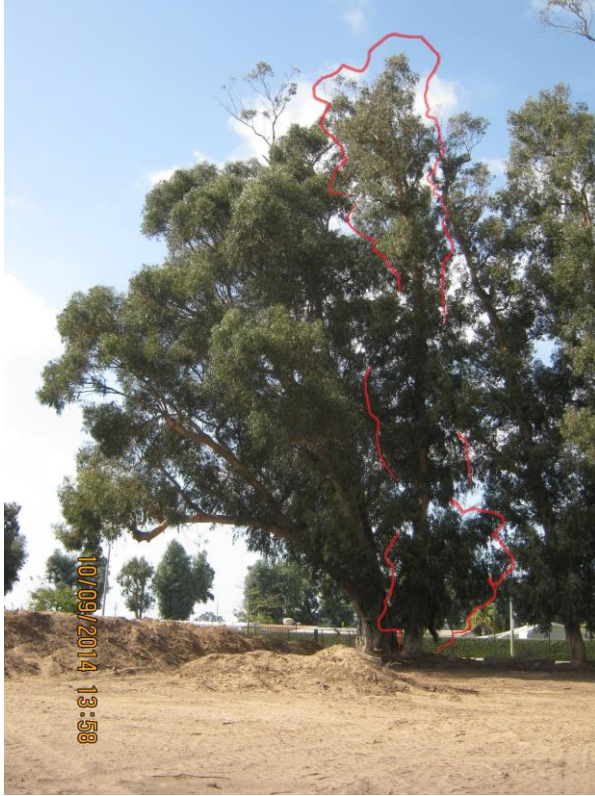
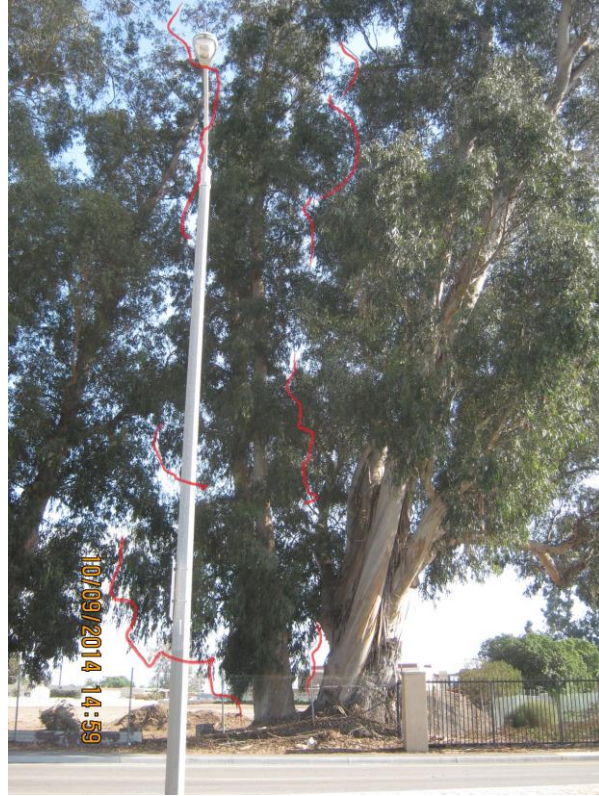
Tree 34, Photos

Above looking north at PVR

Above looking south

Continued risk monitoring is necessary for this tree. This trees should be assessed a year after construction occurs to see if rapid decline has occurred.

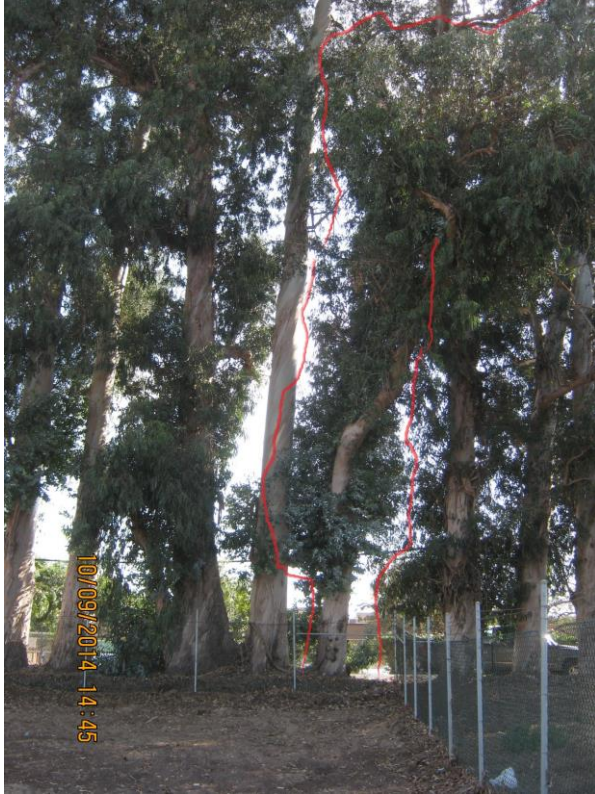
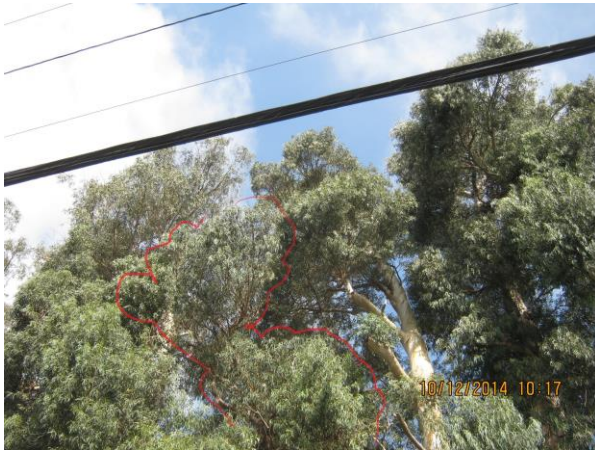
Tree 45, Photos

Above looking south

left looking north

Continued risk monitoring is necessary for this tree. This trees should be assessed a year after construction occurs to see if rapid decline has occurred.

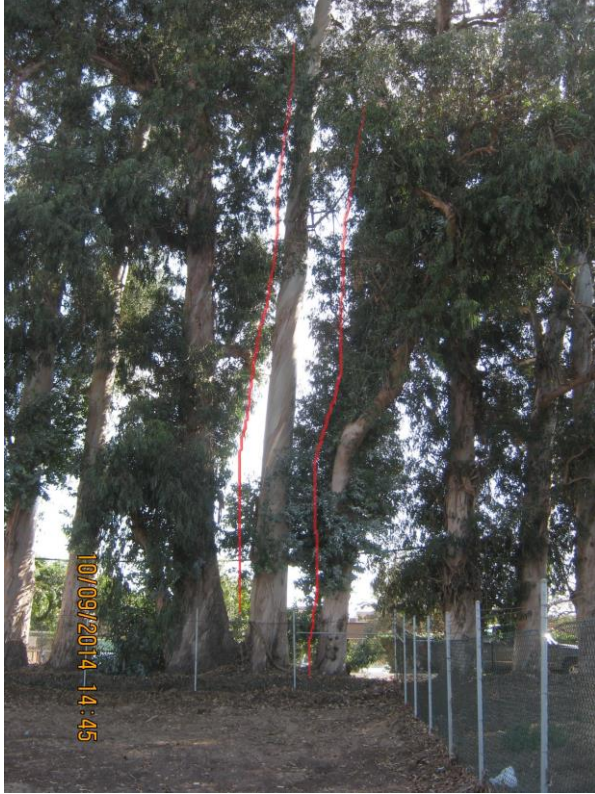
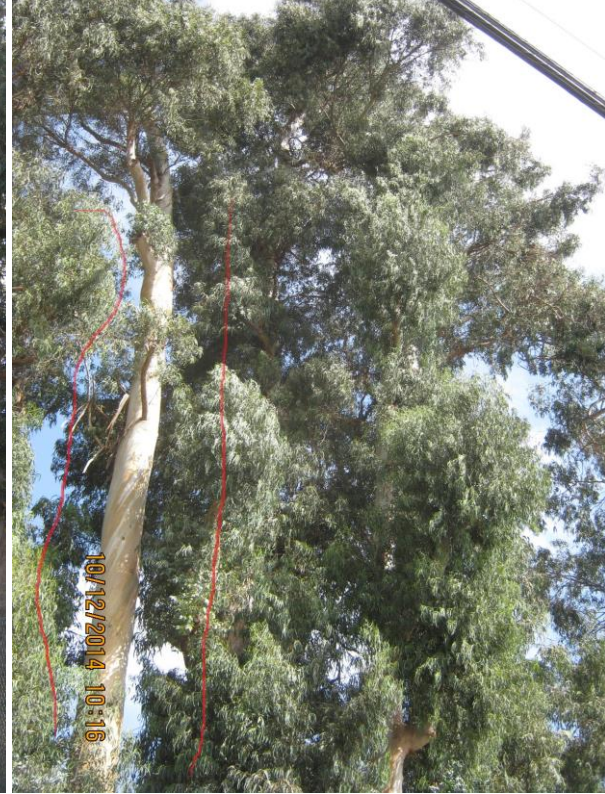
Tree 46, Photos

Above looking south

Above looking north

Continued risk monitoring is necessary for this tree. This trees should be assessed a year after construction occurs to see if rapid decline has occurred.

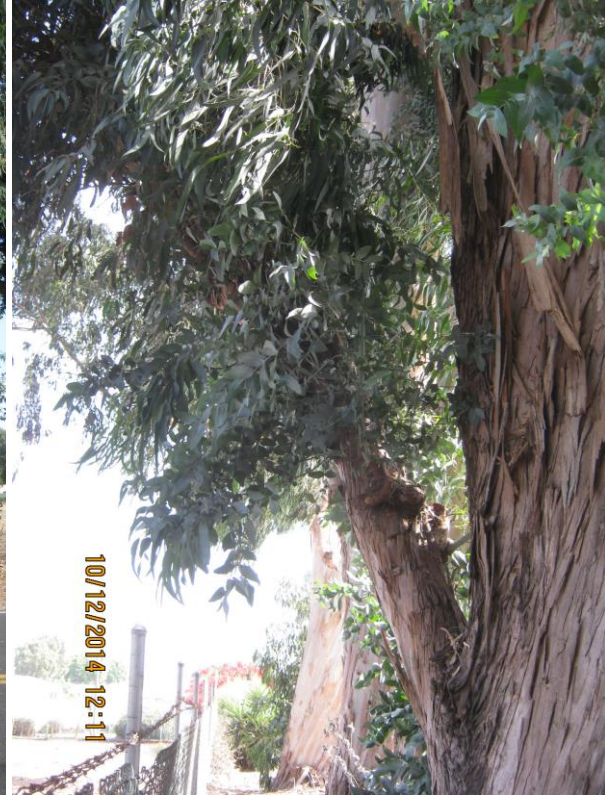
Above looking at branch stub

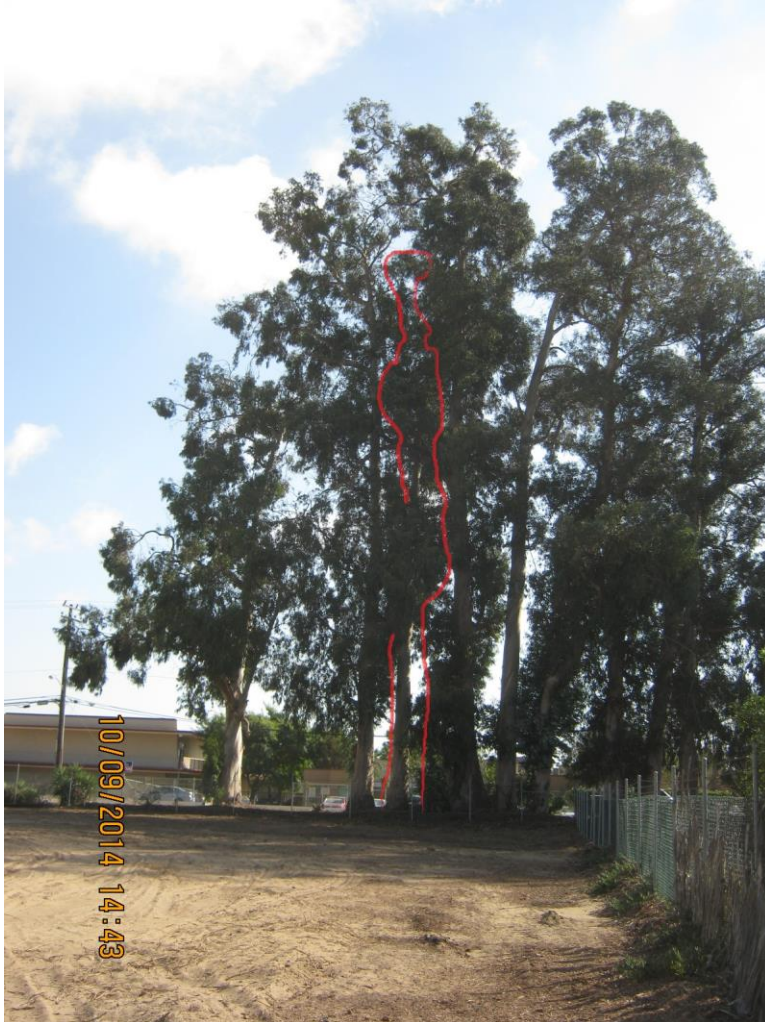
Tree 48, Photos

Above looking south

Continued risk monitoring is necessary for this tree. This trees should be assessed a year after construction occurs to see if rapid decline has occurred.

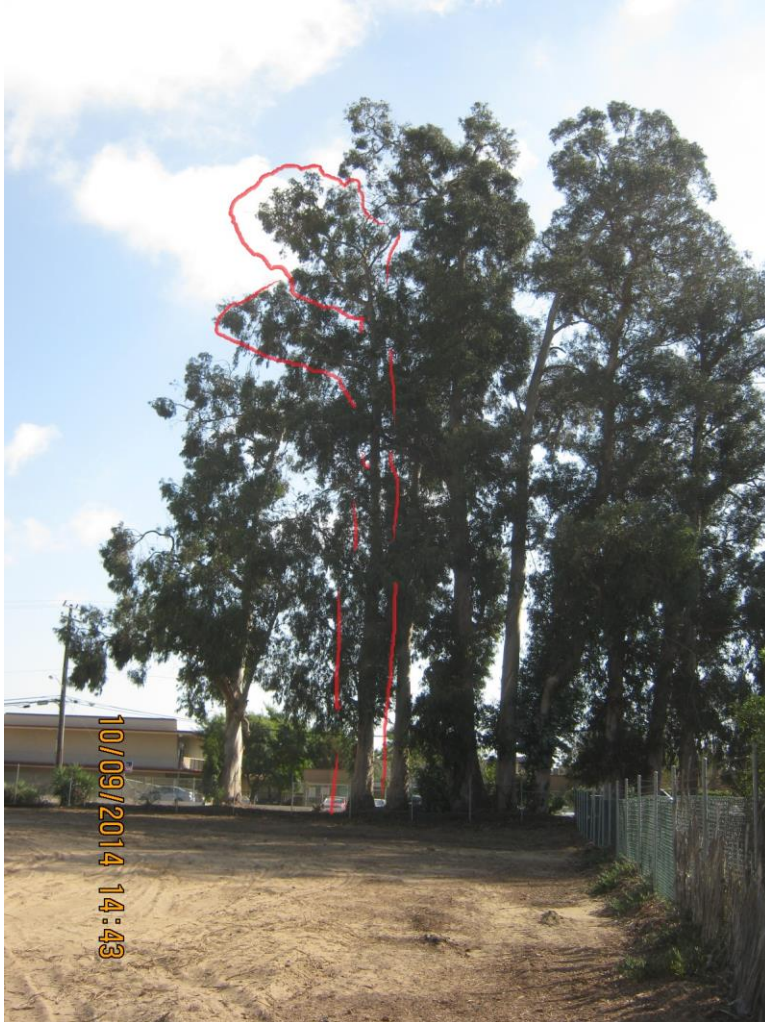
Tree 49, Photos

Above looking south

Continued risk monitoring is necessary for this tree. This trees should be assessed a year after construction occurs to see if rapid decline has occurred.

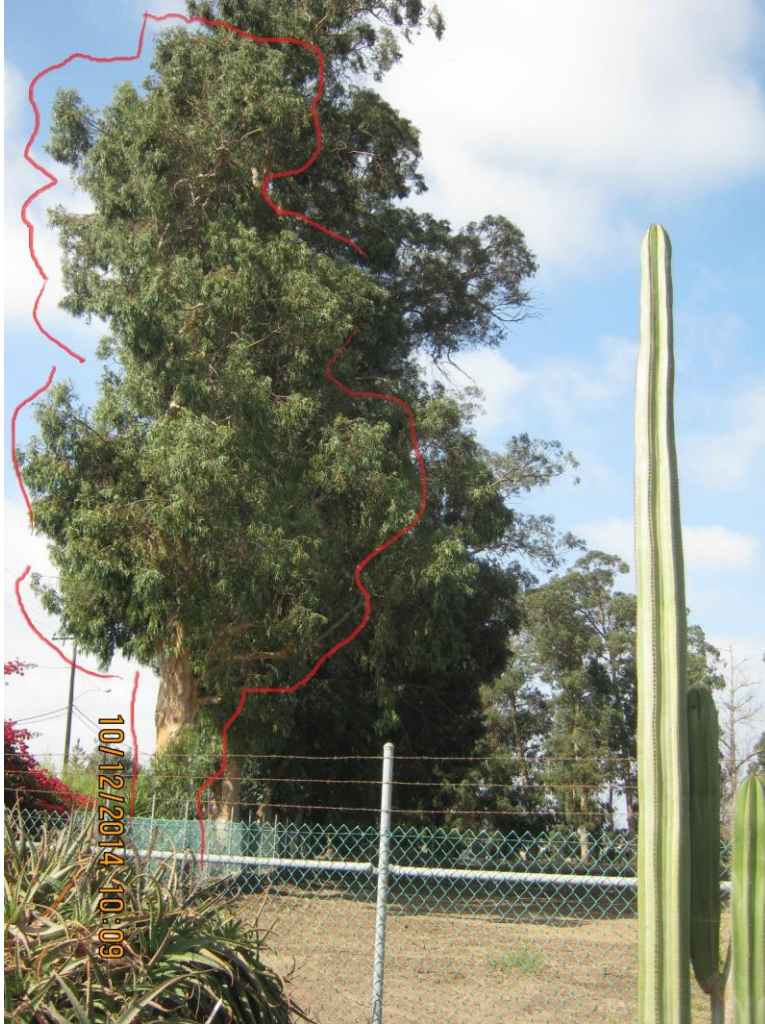
Tree 50, Photos

Above looking south

Continued risk monitoring is necessary for this tree. This trees should be assessed a year after construction occurs to see if rapid decline has occurred.

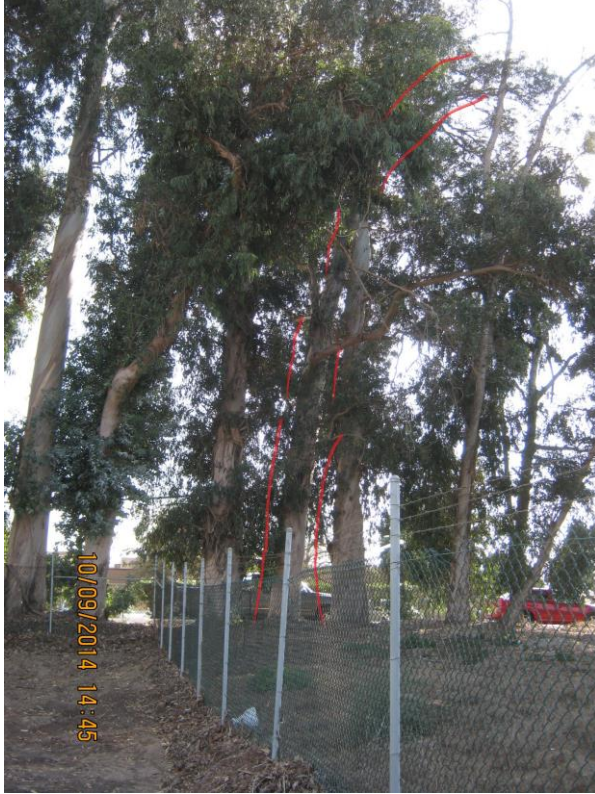
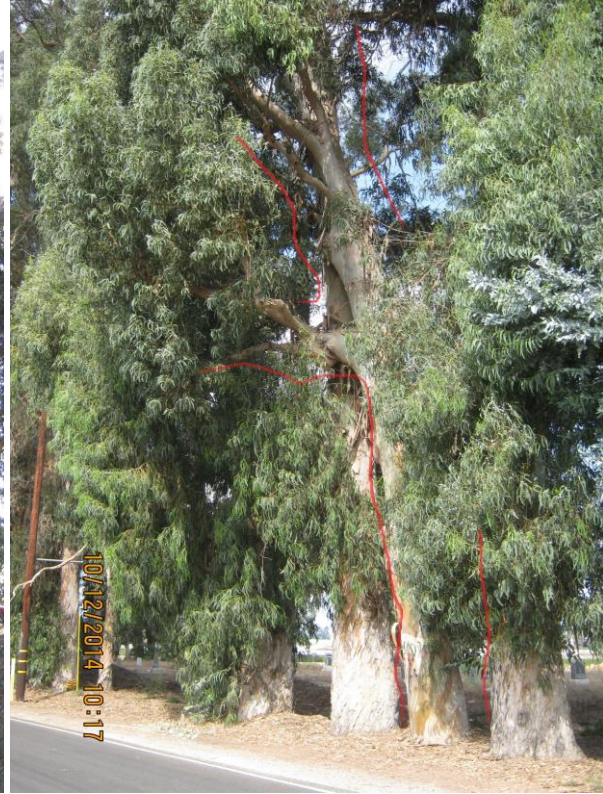
Offsite Tree 73\*, Photos

Above looking north

Above looking south

Continued risk monitoring is necessary for this tree. This trees should be assessed a year after construction occurs to see if rapid decline has occurred.

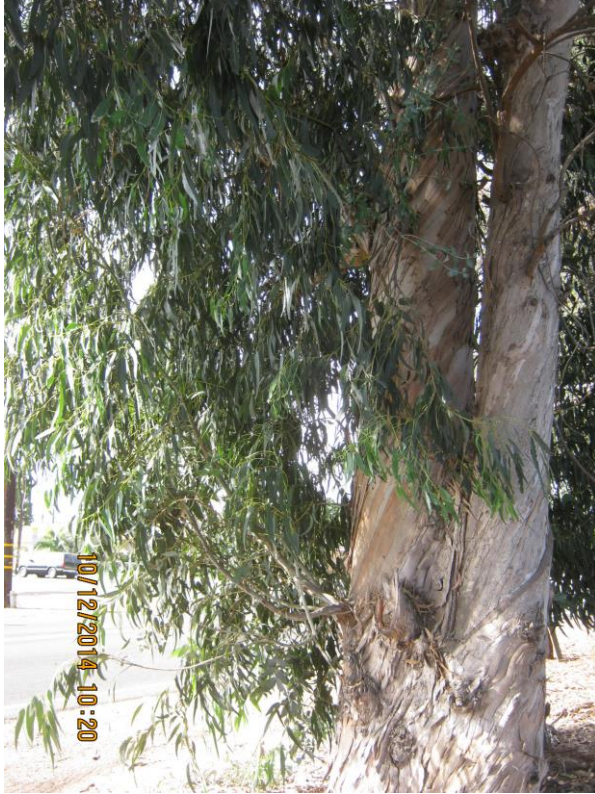
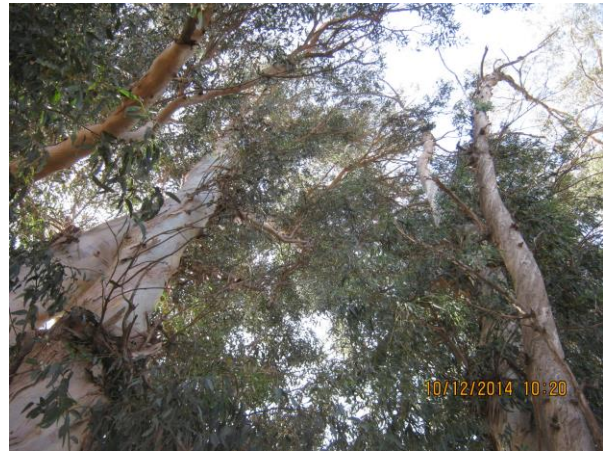
Offsite Tree 75\*, Photos

Above looking west

Continued risk monitoring is necessary for this tree. This trees should be assessed a year after construction occurs to see if rapid decline has occurred.

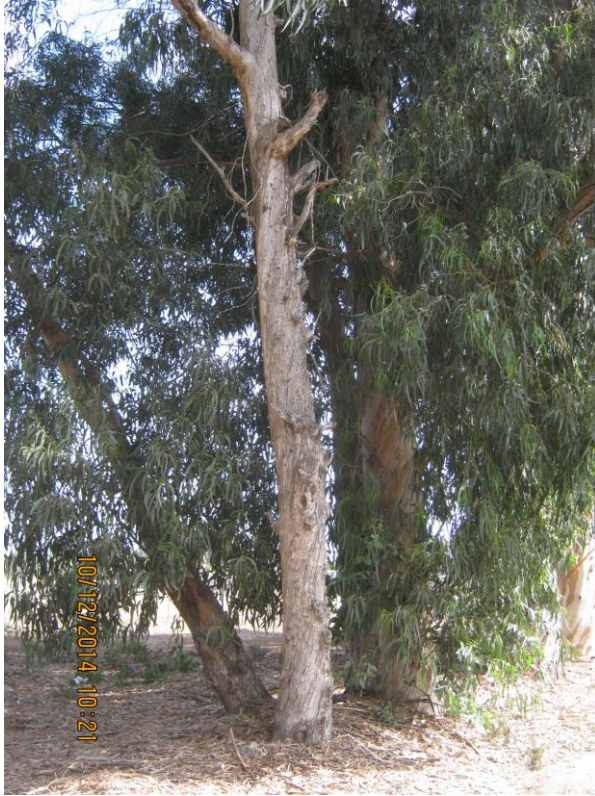
Offsite Tree 76\*, Photos

Above looking north

Continued risk monitoring is necessary for this tree. This trees should be assessed a year after construction occurs to see if rapid decline has occurred.

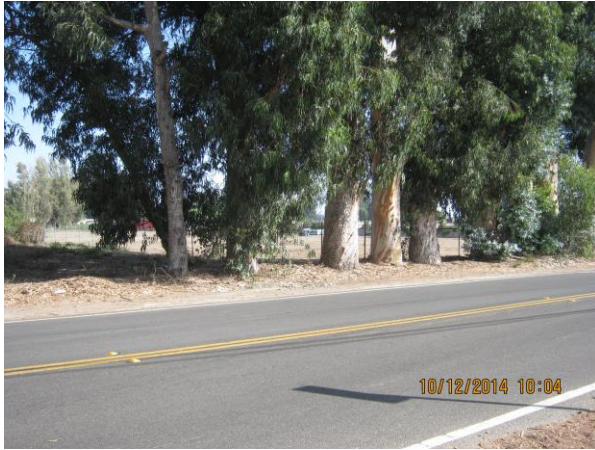
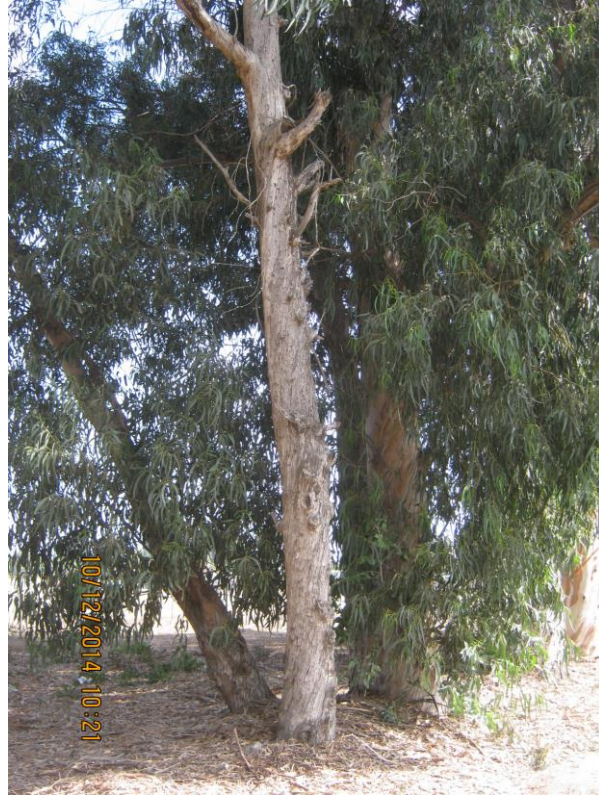
Offsite Tree 77\*, Photos

Above looking north

Above looking northeast

Small size means it will remain a low/medium risk tree that needs reassessed in 1 years.

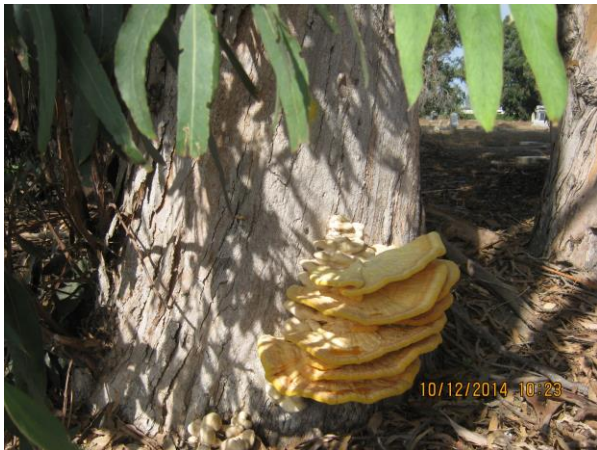
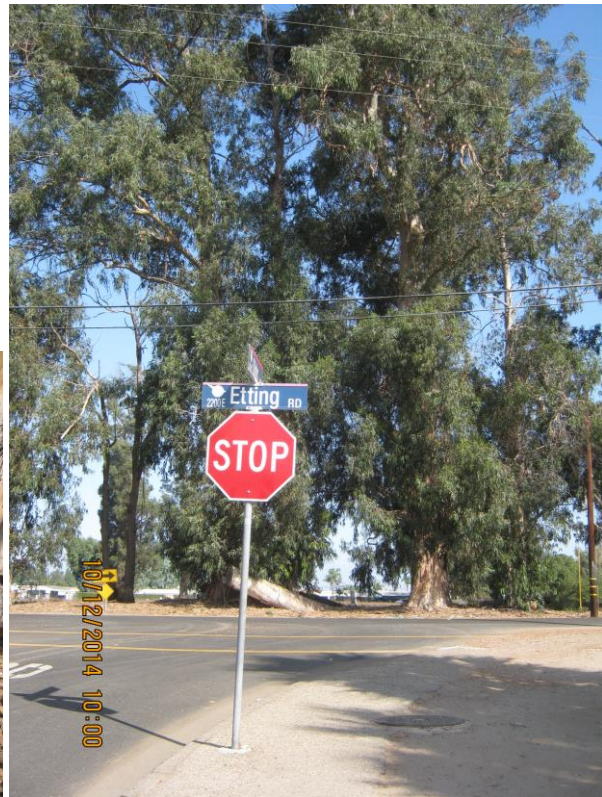
Offsite Trees 78\* and others to the west of site on north side of Etting Road.

These trees are in bad shade with signs of extensive internal decay. Collapsed trunks. Many dead and hang dead branches, dead thin stressed canopies

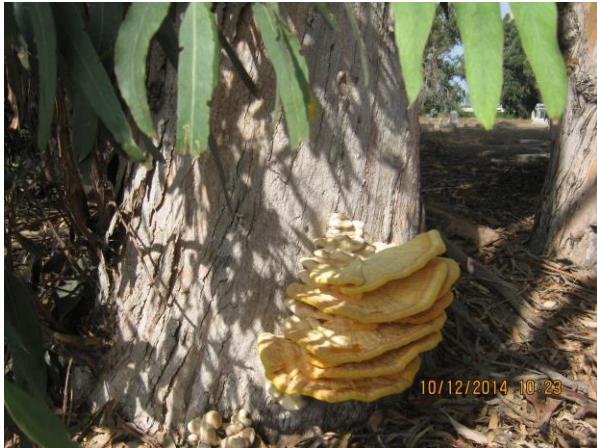
Photos

These trees are in bad shade with signs of extensive internal decay. Collapsed trunks. Many dead and hang dead branches, dead thin stressed canopies

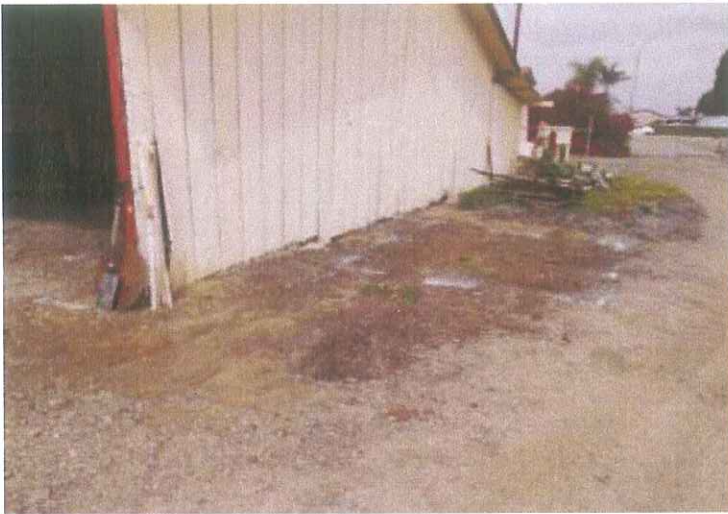
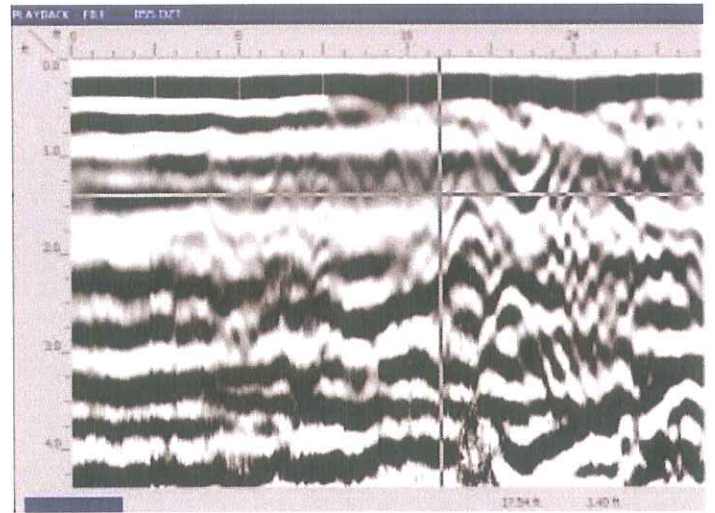
Fig. 1 - Photo and saved GPR file of a former Underground Storage Tank confirmed in the northwest section of the property next to an existing building on-site. Saved GPR file shows evidence of excavation, with normal soil lithology to the left of the cross point and disturbed soil lithology to the right.

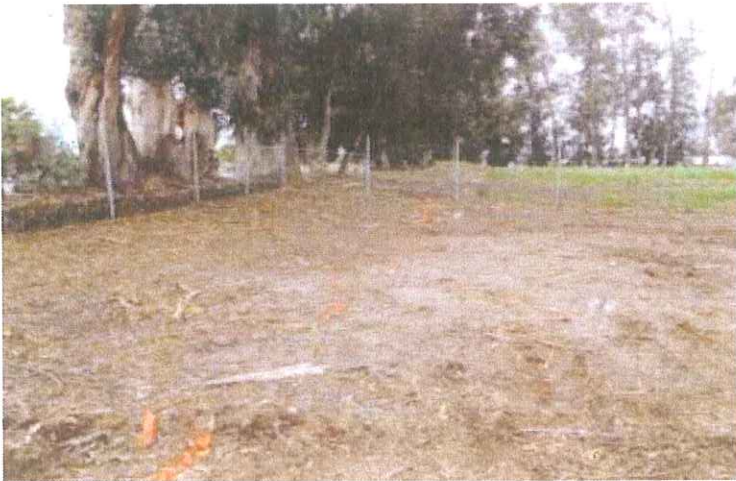
Fig 2 – Photo and saved GPR file of a buried concrete water line confirmed in the southeast corner of the property closest to Etting Rd.

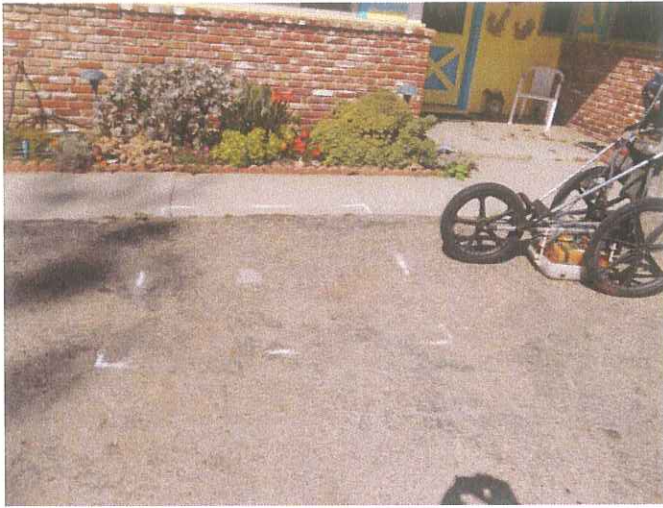
Fig. 1 - Photo and saved GPR file of a possible buried septic tank confirmed on the east side of the of the existing house property.

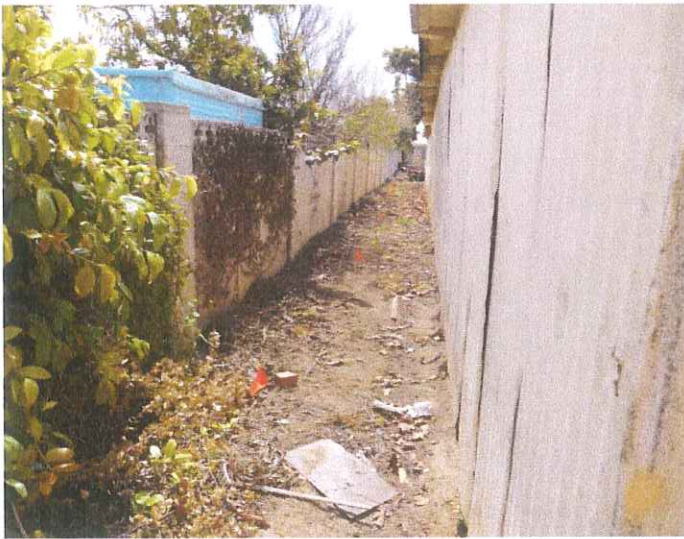
Fig 2 – Photo and saved GPR file of a disturbed soil and area of debris confirmed behind the northeast storage building on-site. Orange survey flags delineate the disturbed soil confirmed in the area.

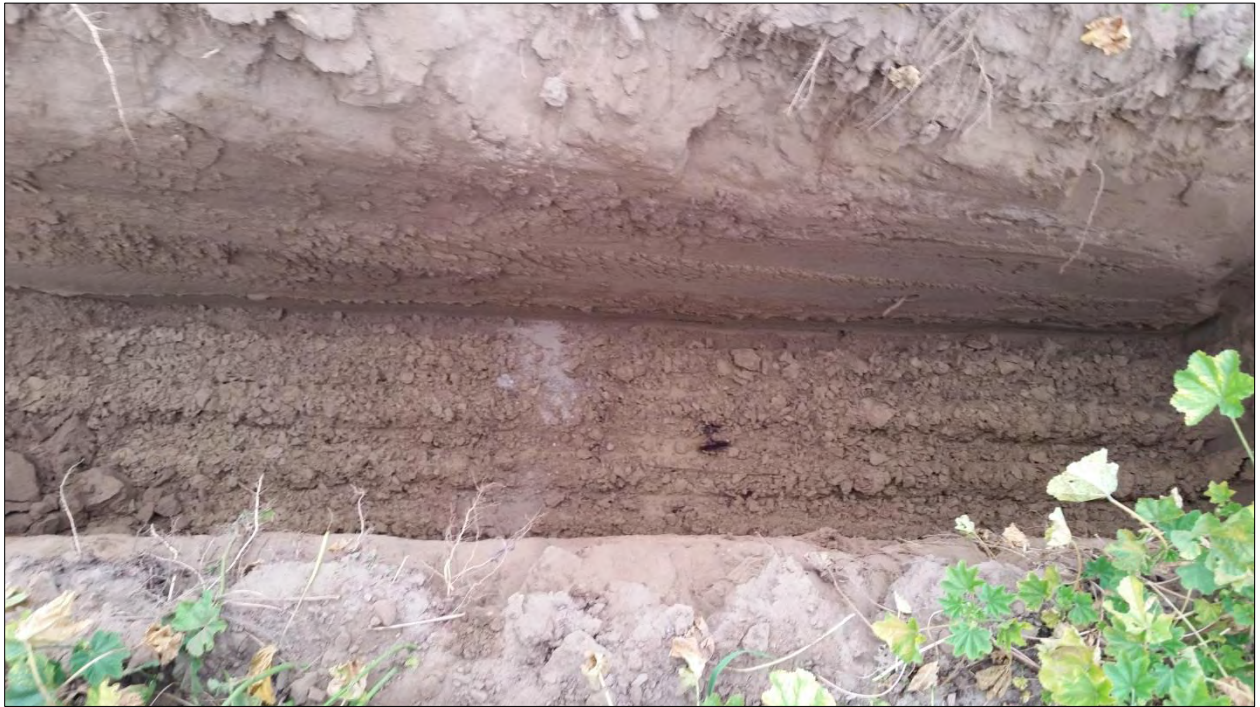
Photograph 1. Overview of Trench 1, detail

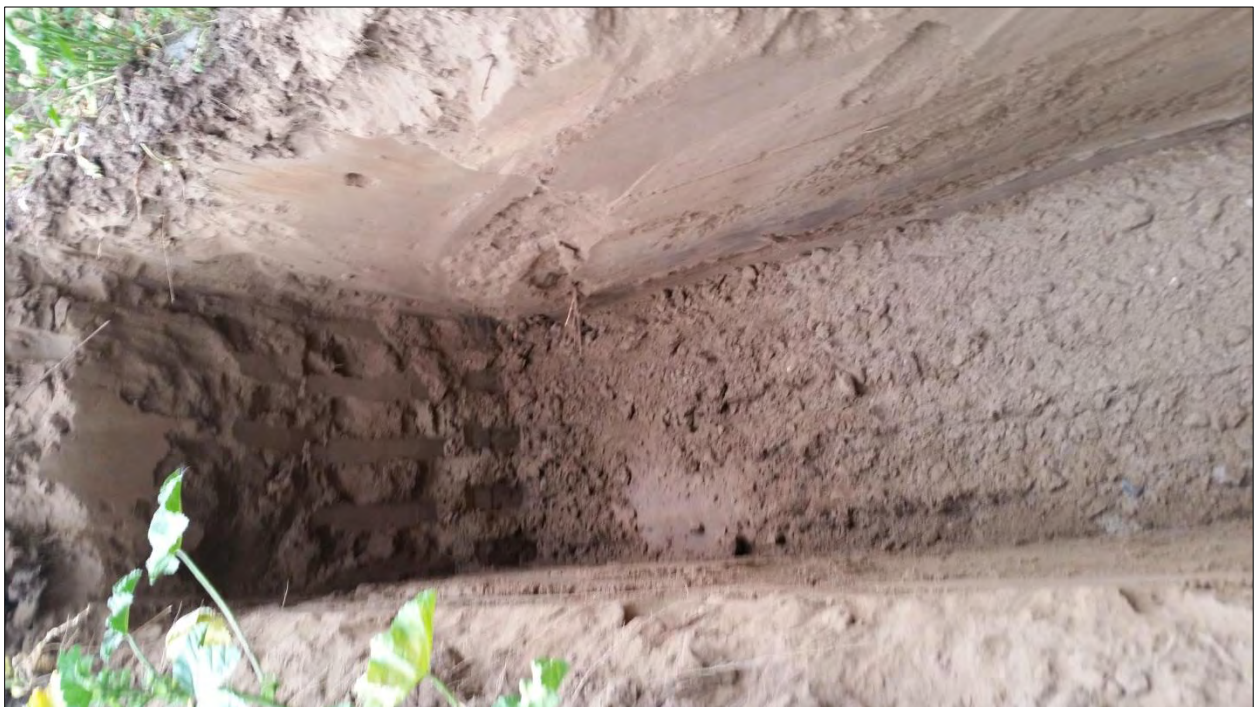
Photograph 2. Overview of Trench 2, detail

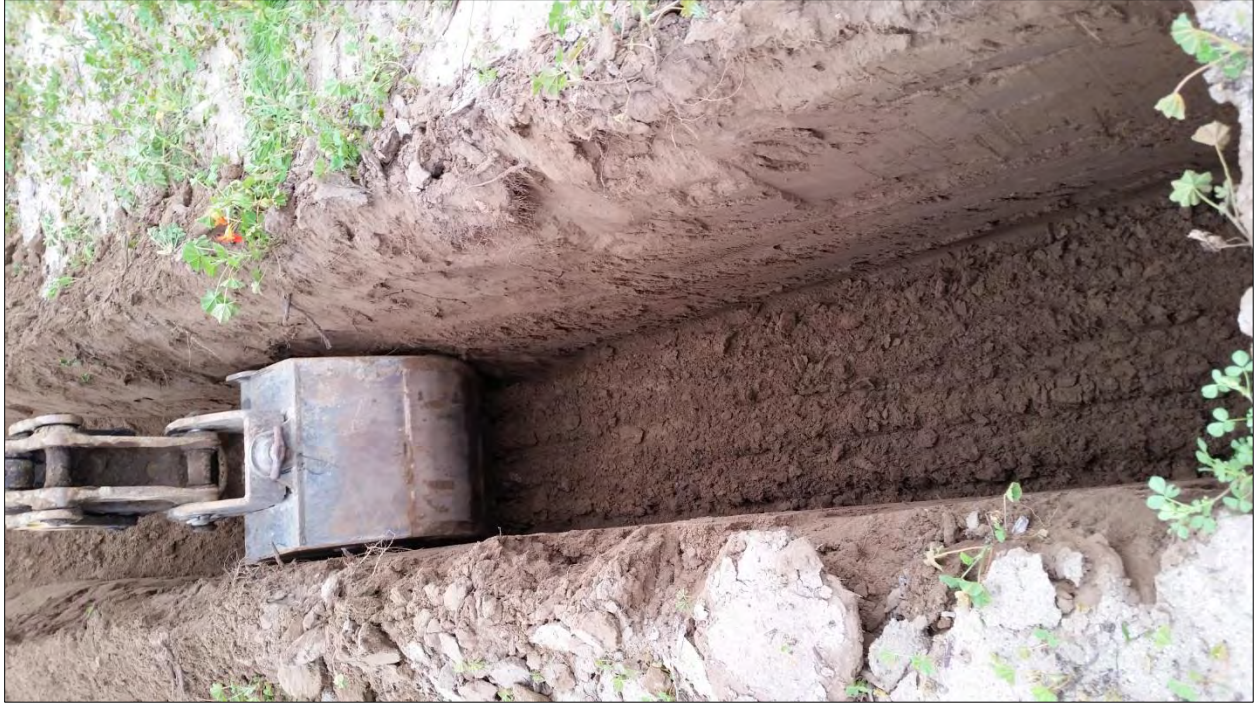
Photograph 3. Overview of Trench 3, detail

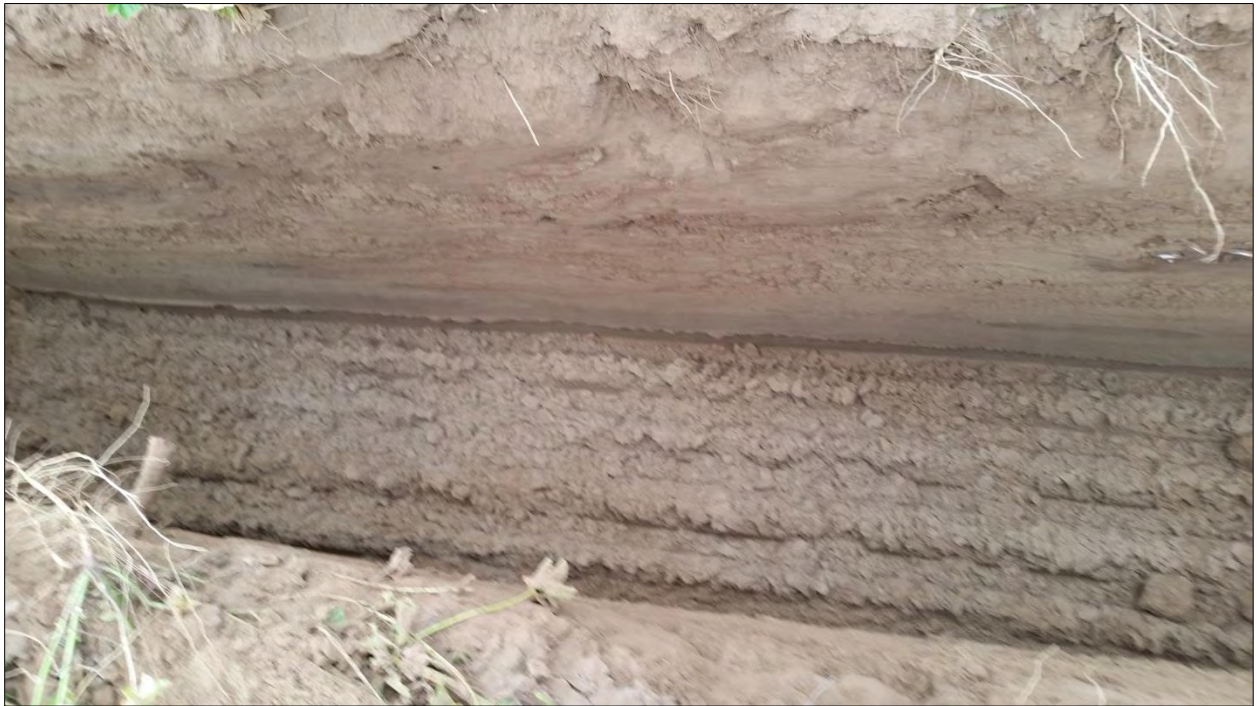
Photograph 4. Overview of Trench 4, detail

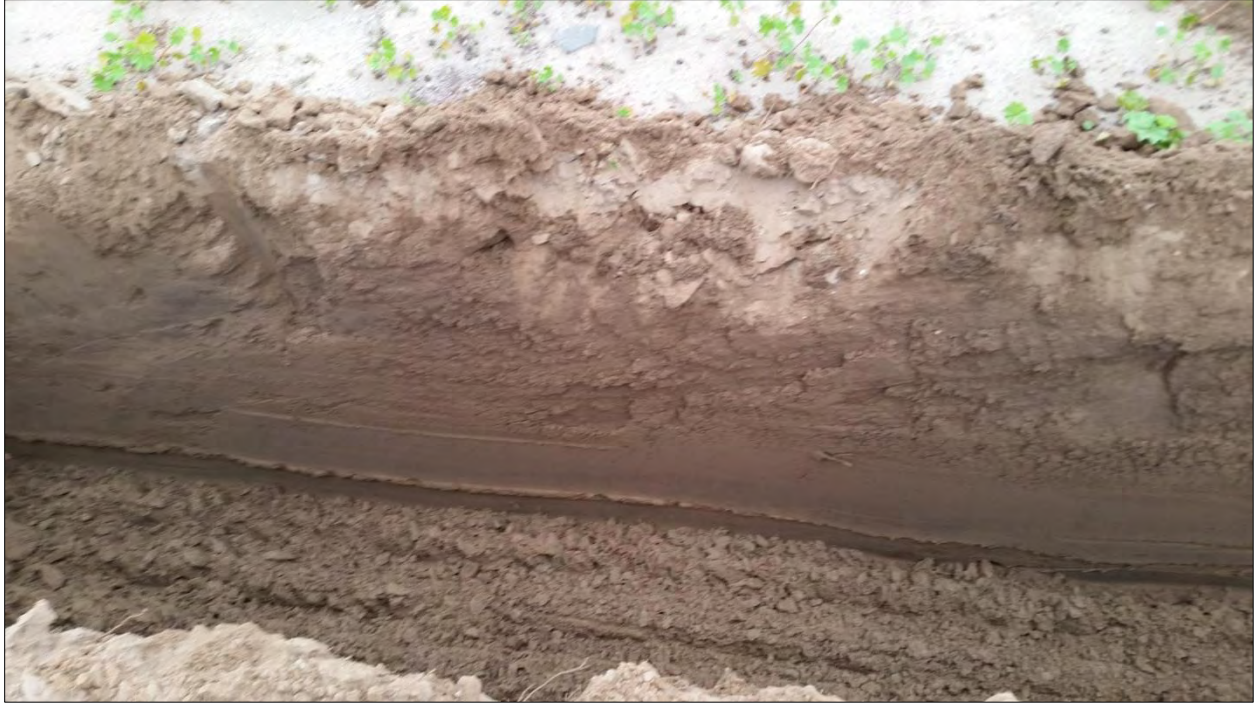
Photograph 5. Overview of Trench 5, detail.
