# **Coastal Apartment Homes Project and Coastal Senior / Assisted Living Project**

*Final*  
**Initial Study/  
Mitigated Negative  
Declaration**

**August 2015**

**Rincon Consultants, Inc.**  
180 Ashwood Ave.  
Ventura, California 93003

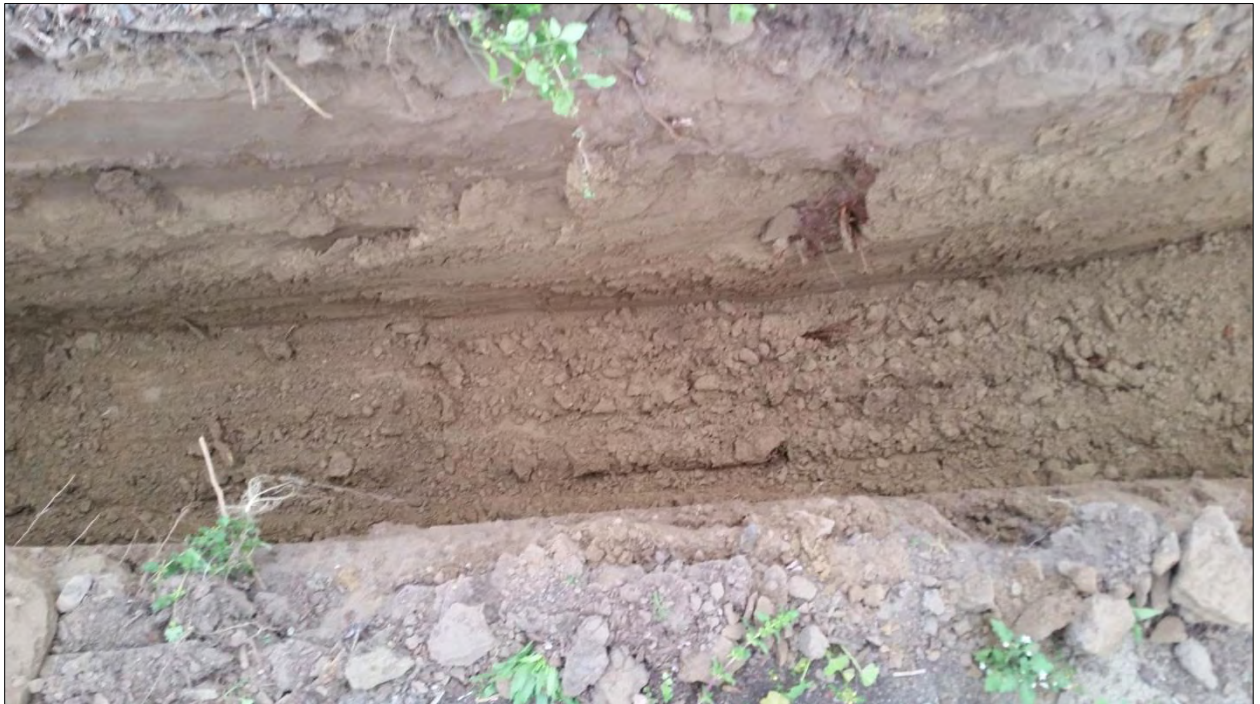
Photograph 6. Overview of Trench 6, detail

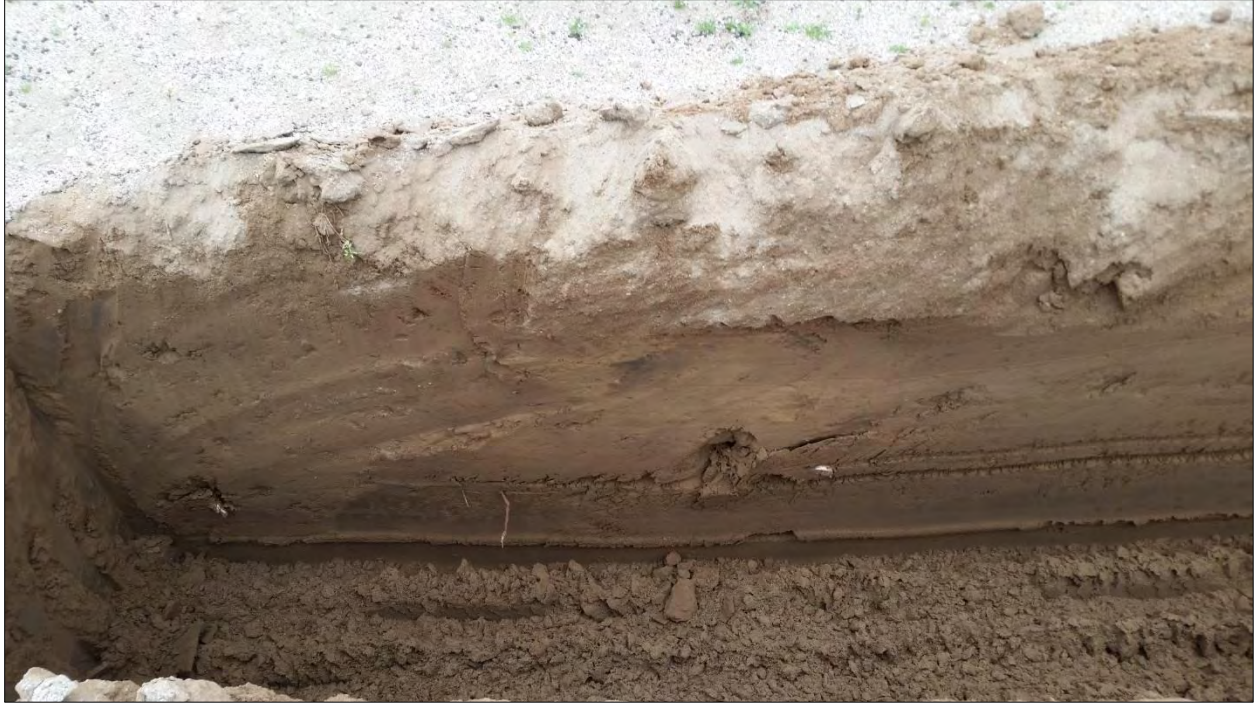
Photograph 7. Overview of Trench 7, detail.

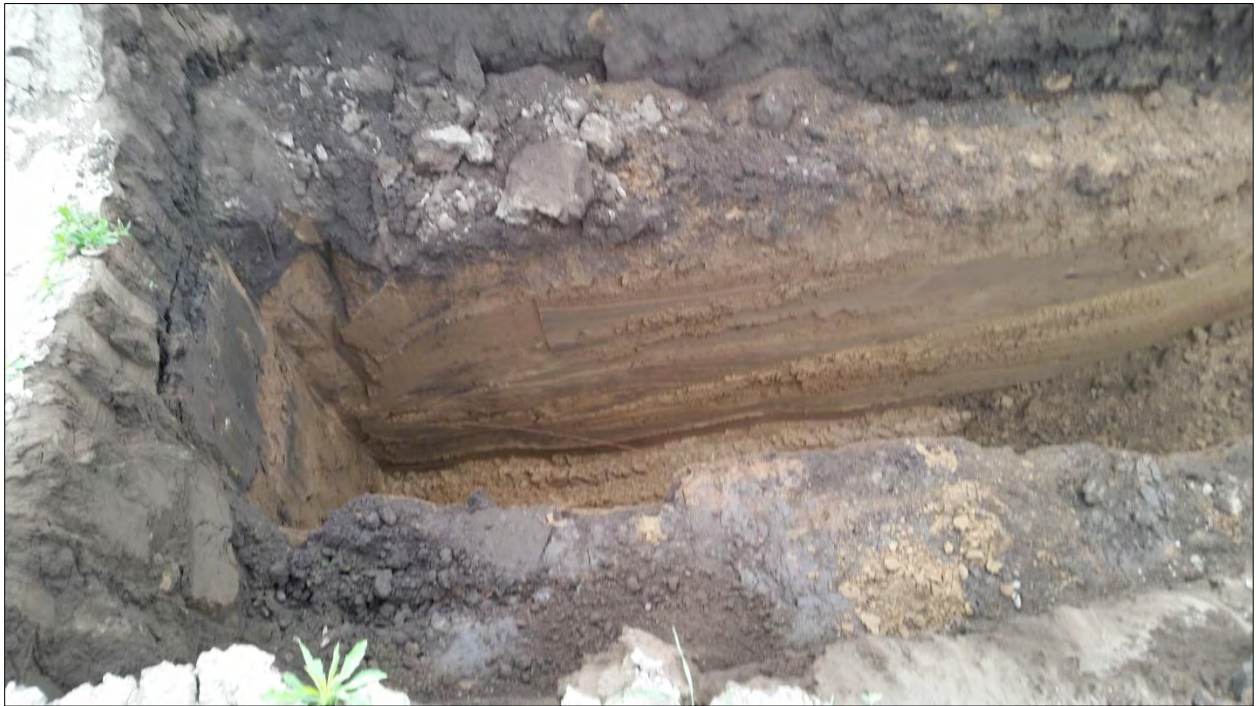
Photograph 8. Overview of Trench 8, detail.

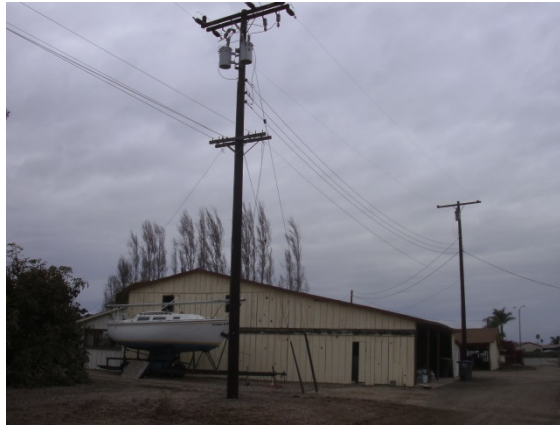
**Photograph 2.** View of the two pole mounted transformers, barn and attached residence on the eastern portion of the subject property, facing northwest.

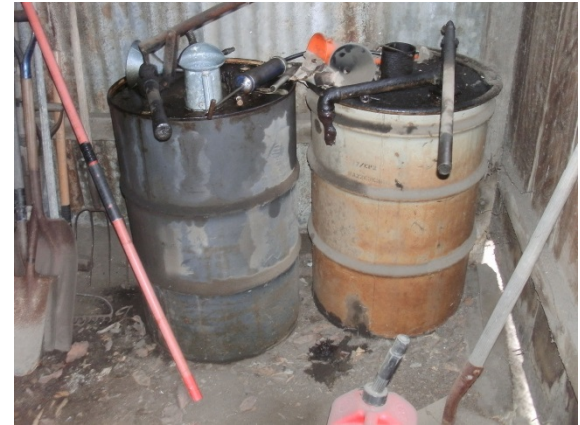
**Photograph 3.** View of the two 55-gallon drums containing used motor oil located in the storage shed.

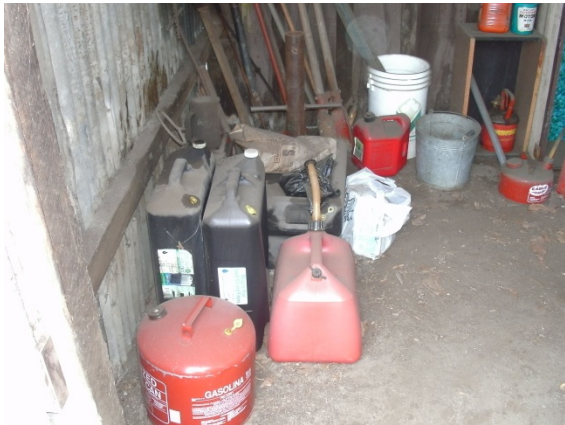
**Photograph 4.** View of several fuel containers located in the storage shed

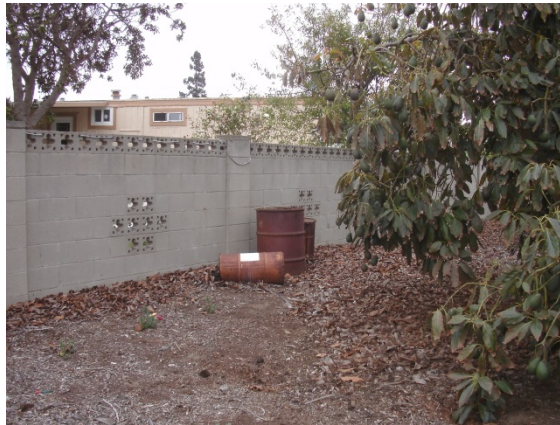
**Photograph 5.** View of the one 55-gallon drum and two smaller drums located on the eastern portion of the subject property, facing southeast.

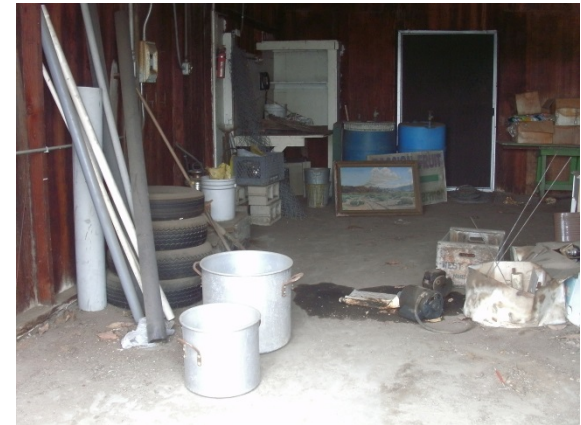
**Photograph 6.** View of the minor motor oil staining on the concrete flooring in the southern portion of the storage/workshop structure on the eastern portion of the subject property.

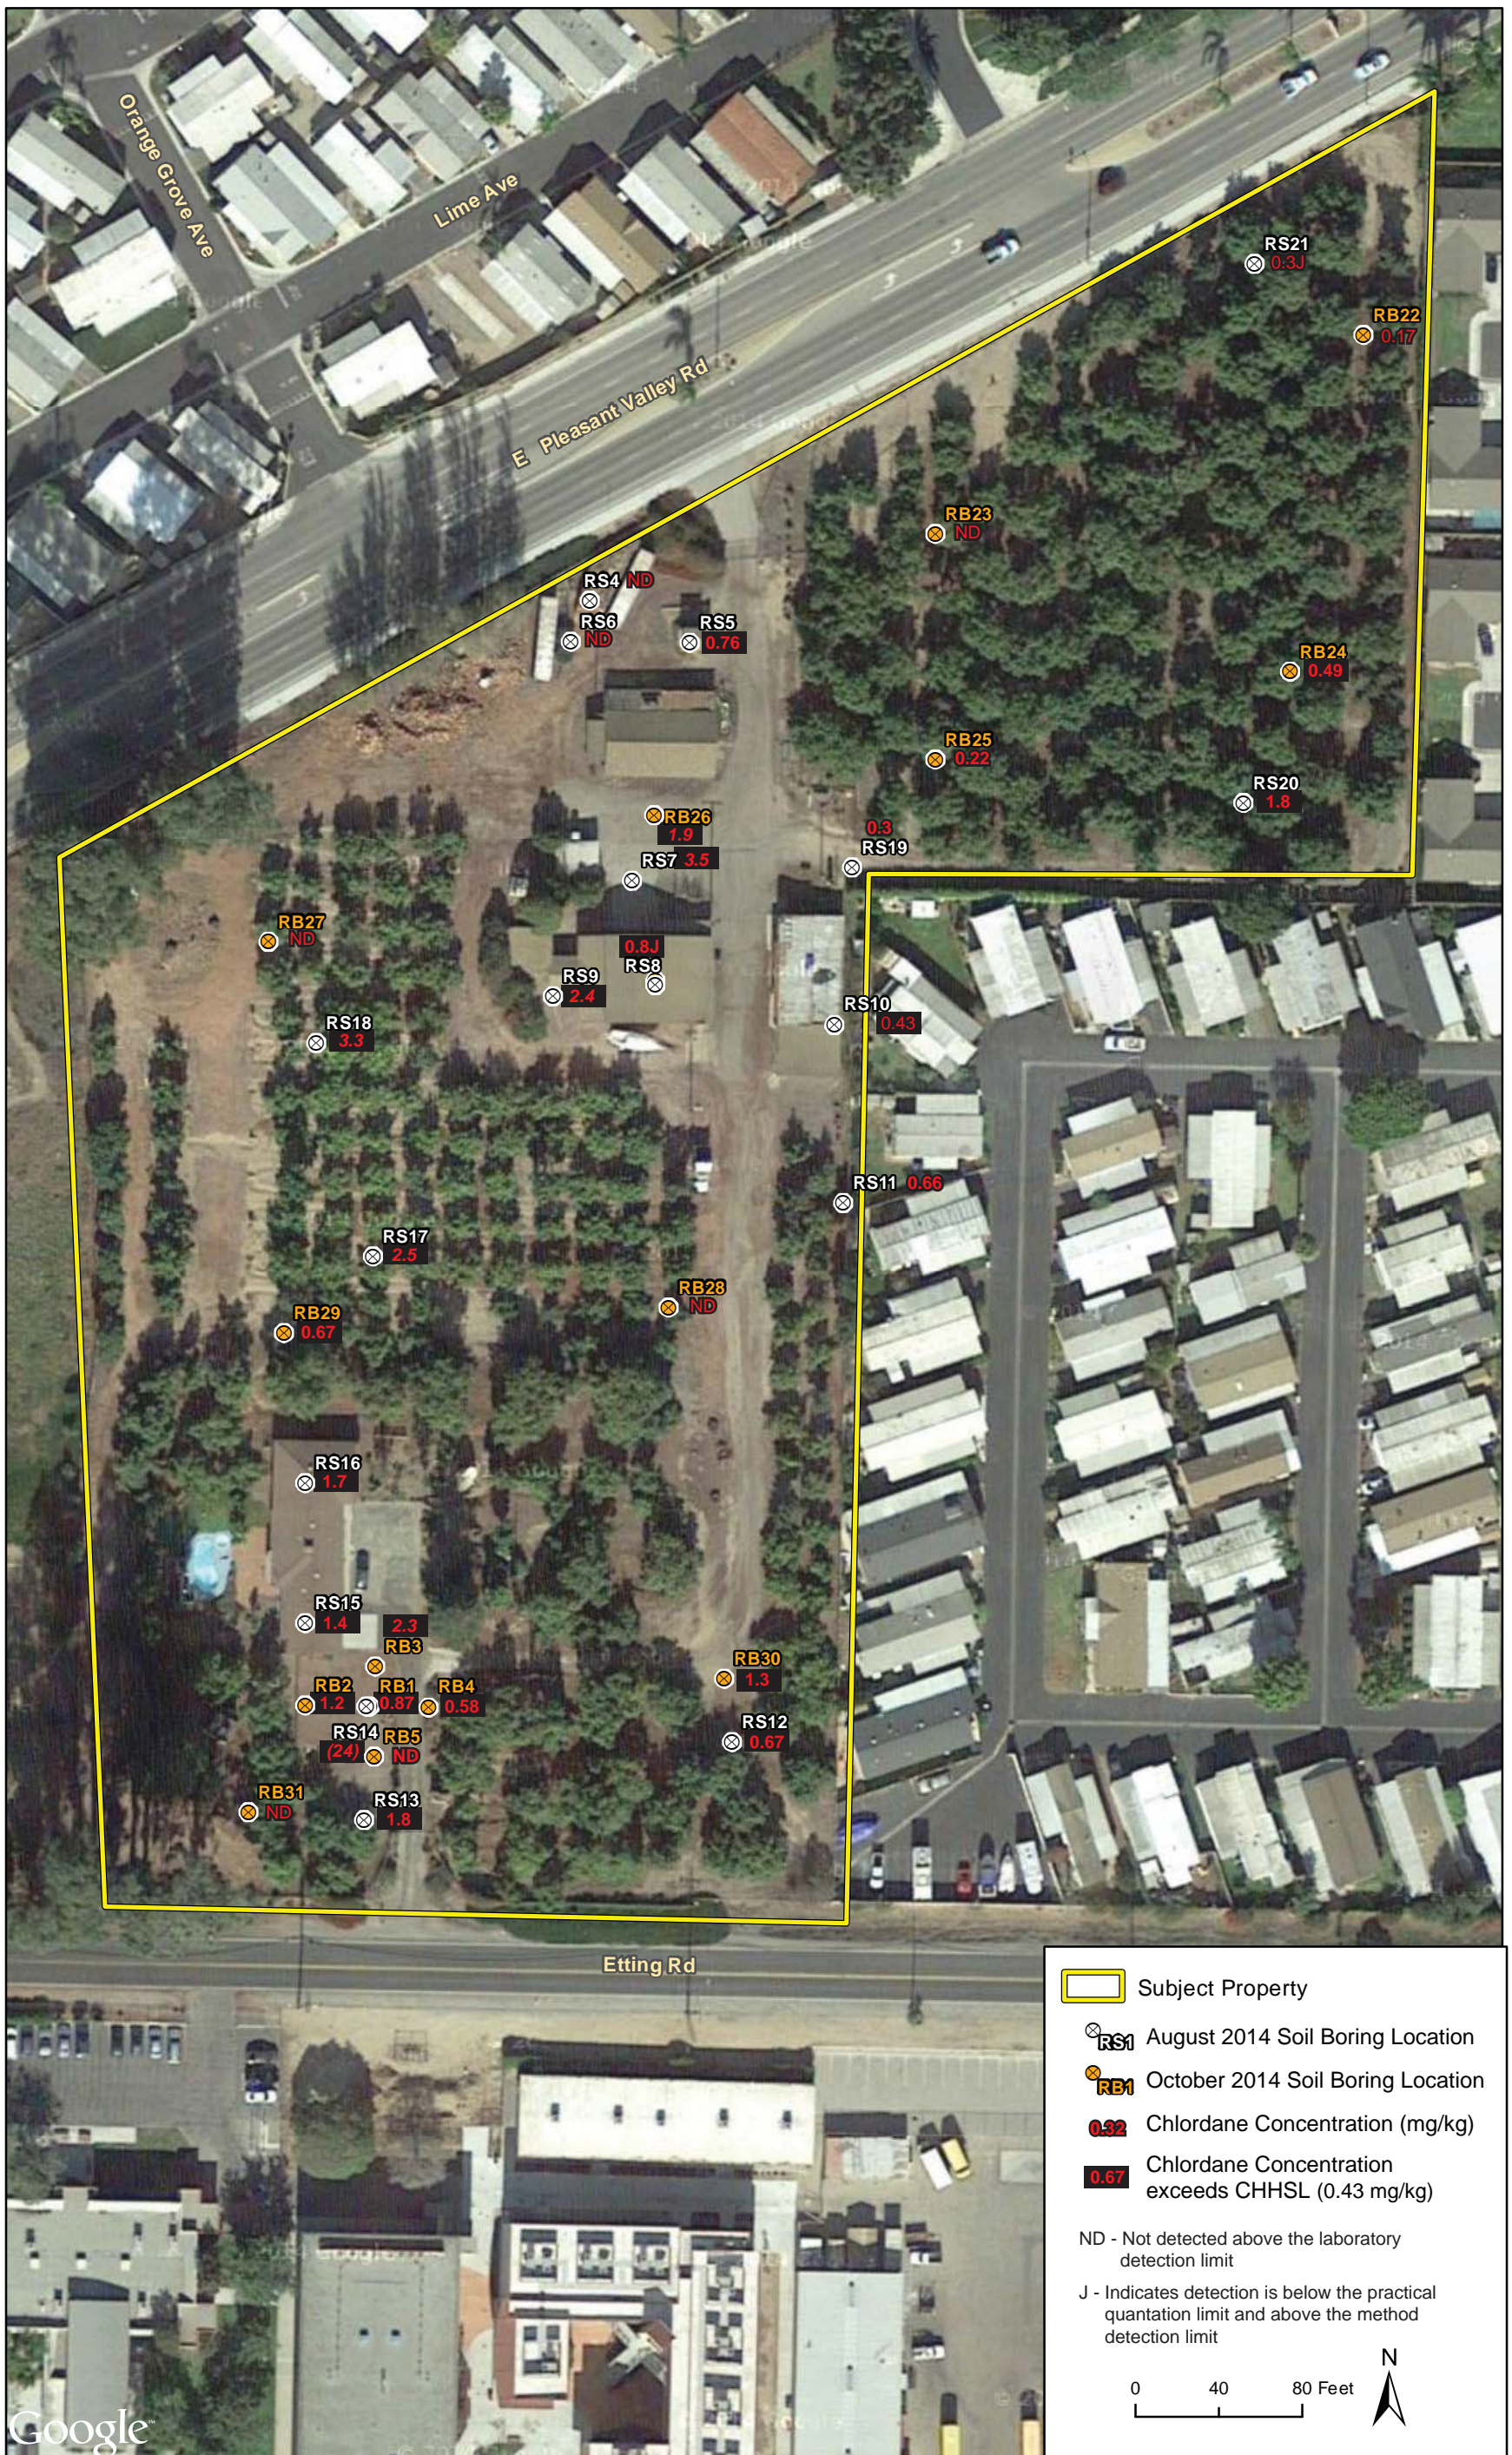
Figure 2

Chlordane Concentrations in Surface Samples

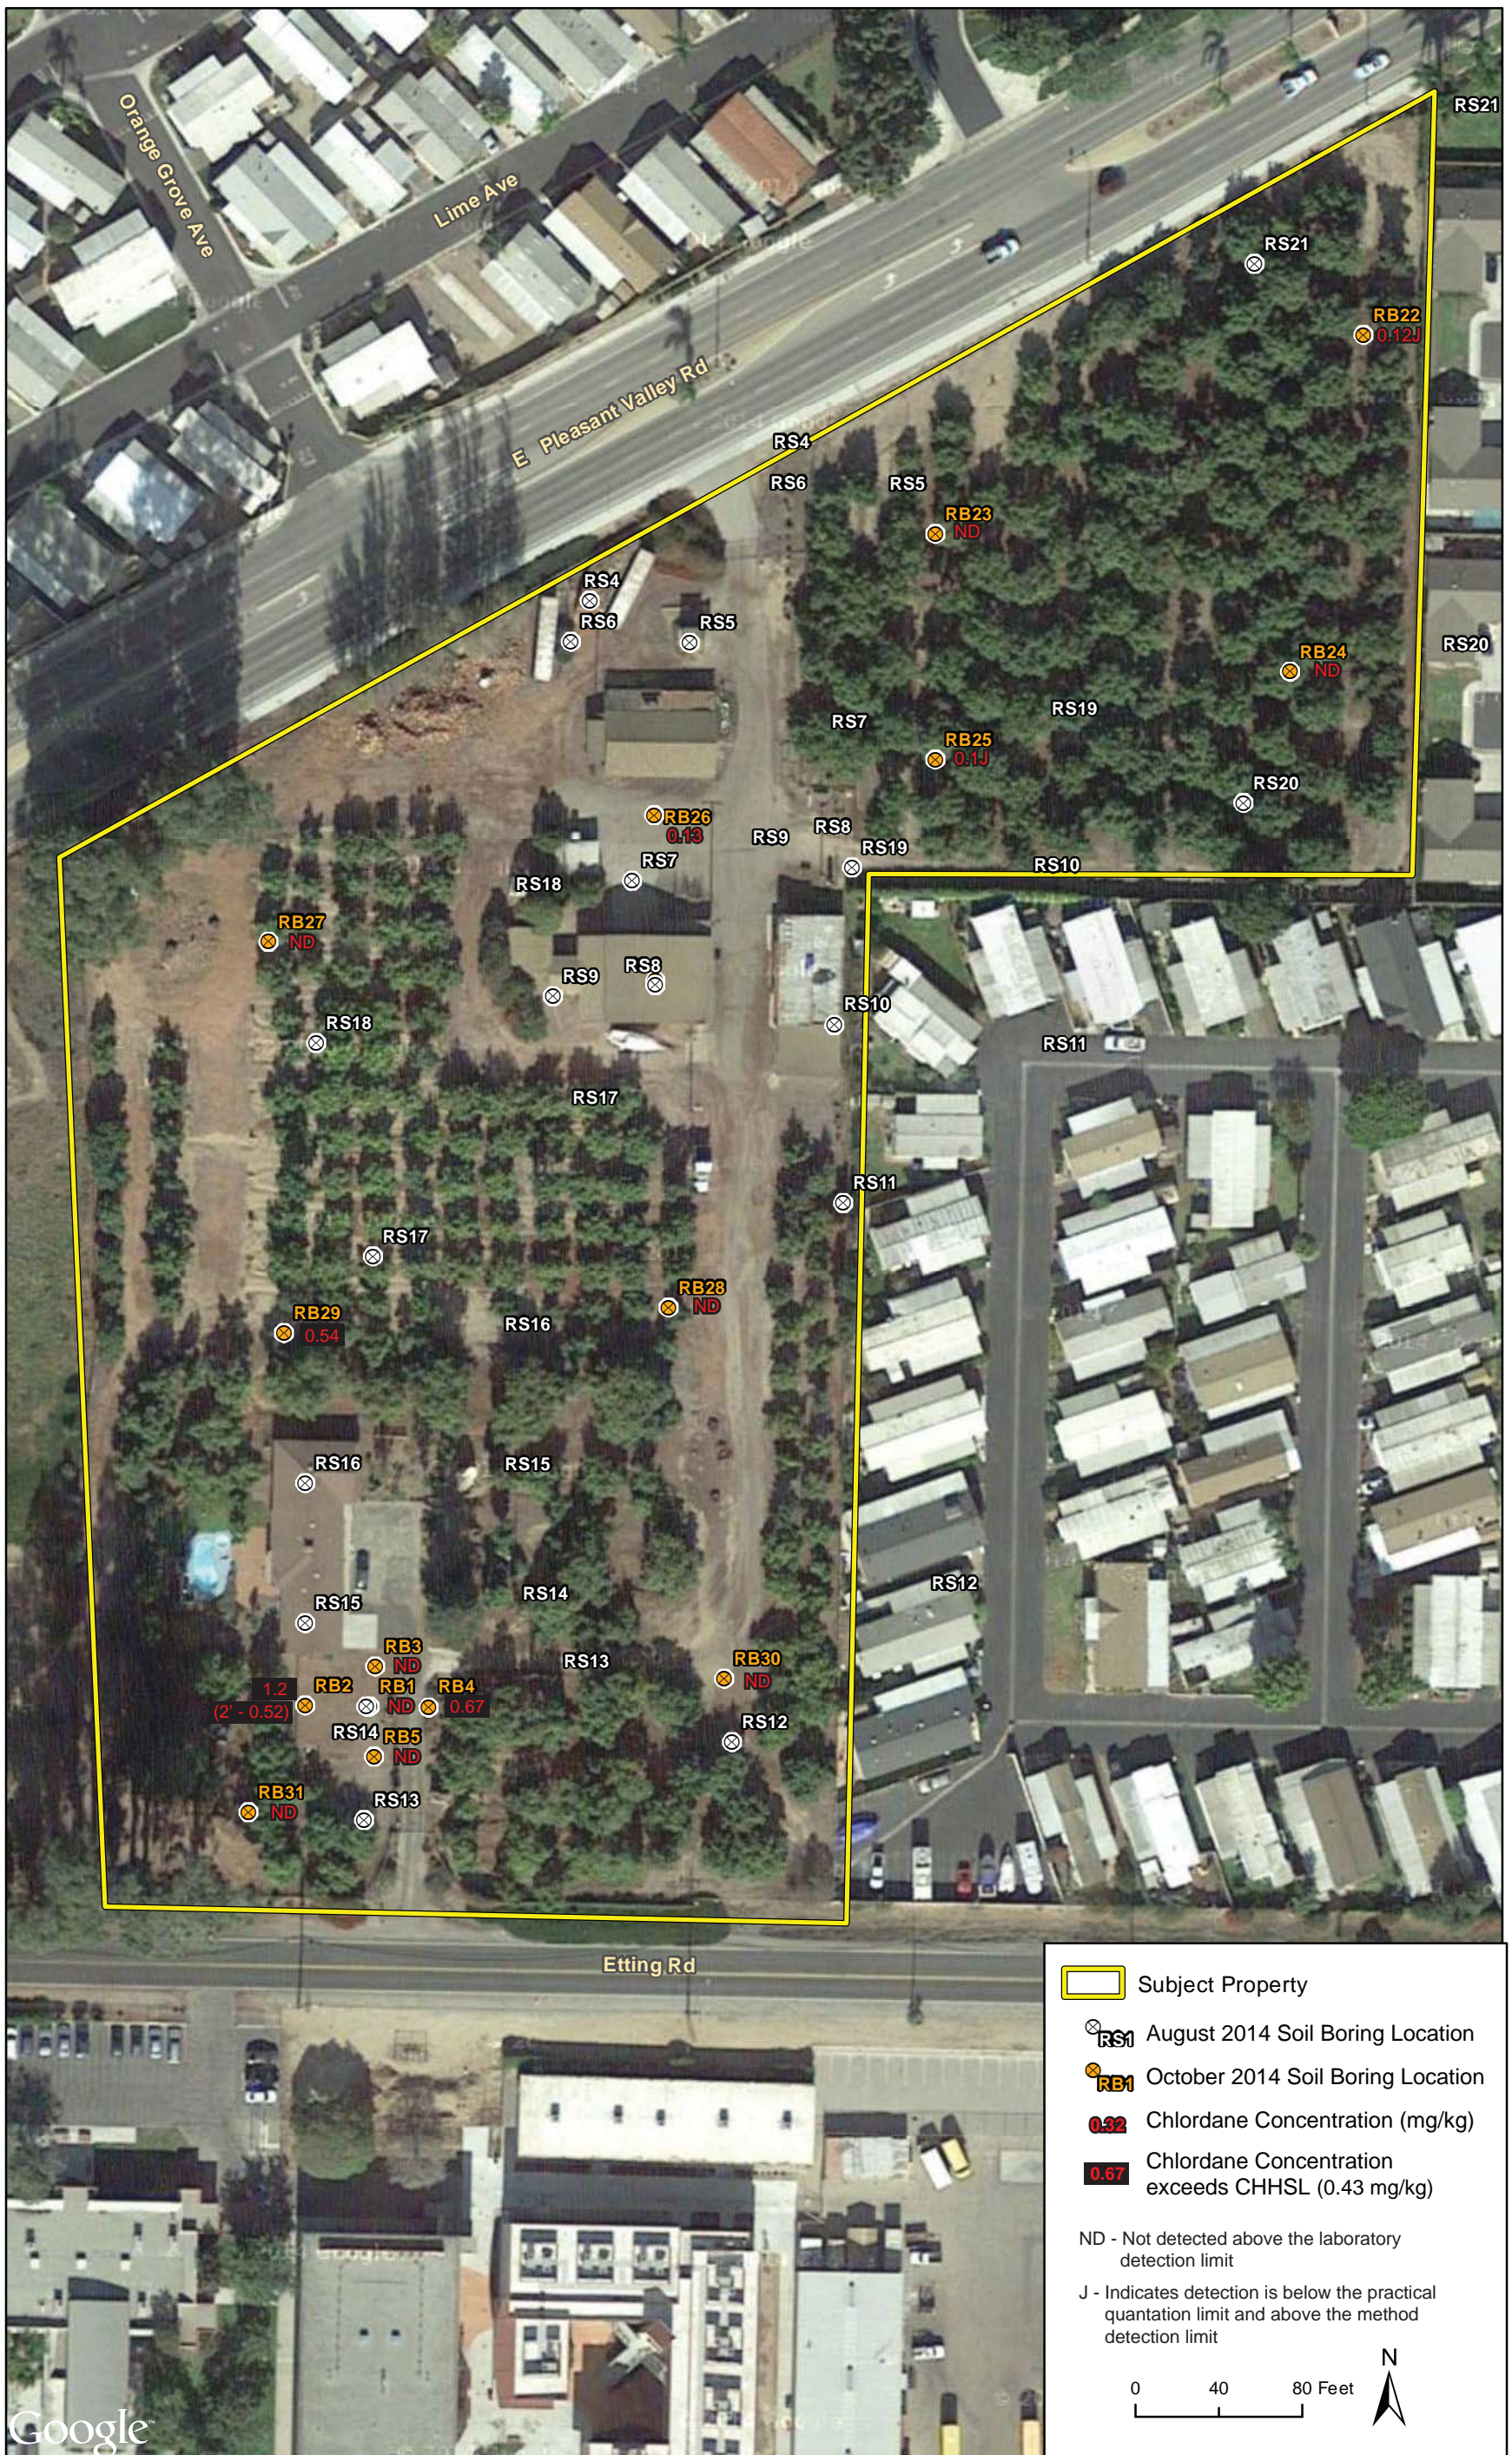
Figure 3

Chlordane Concntrations in Soil Samples 1 Foot Below Grade

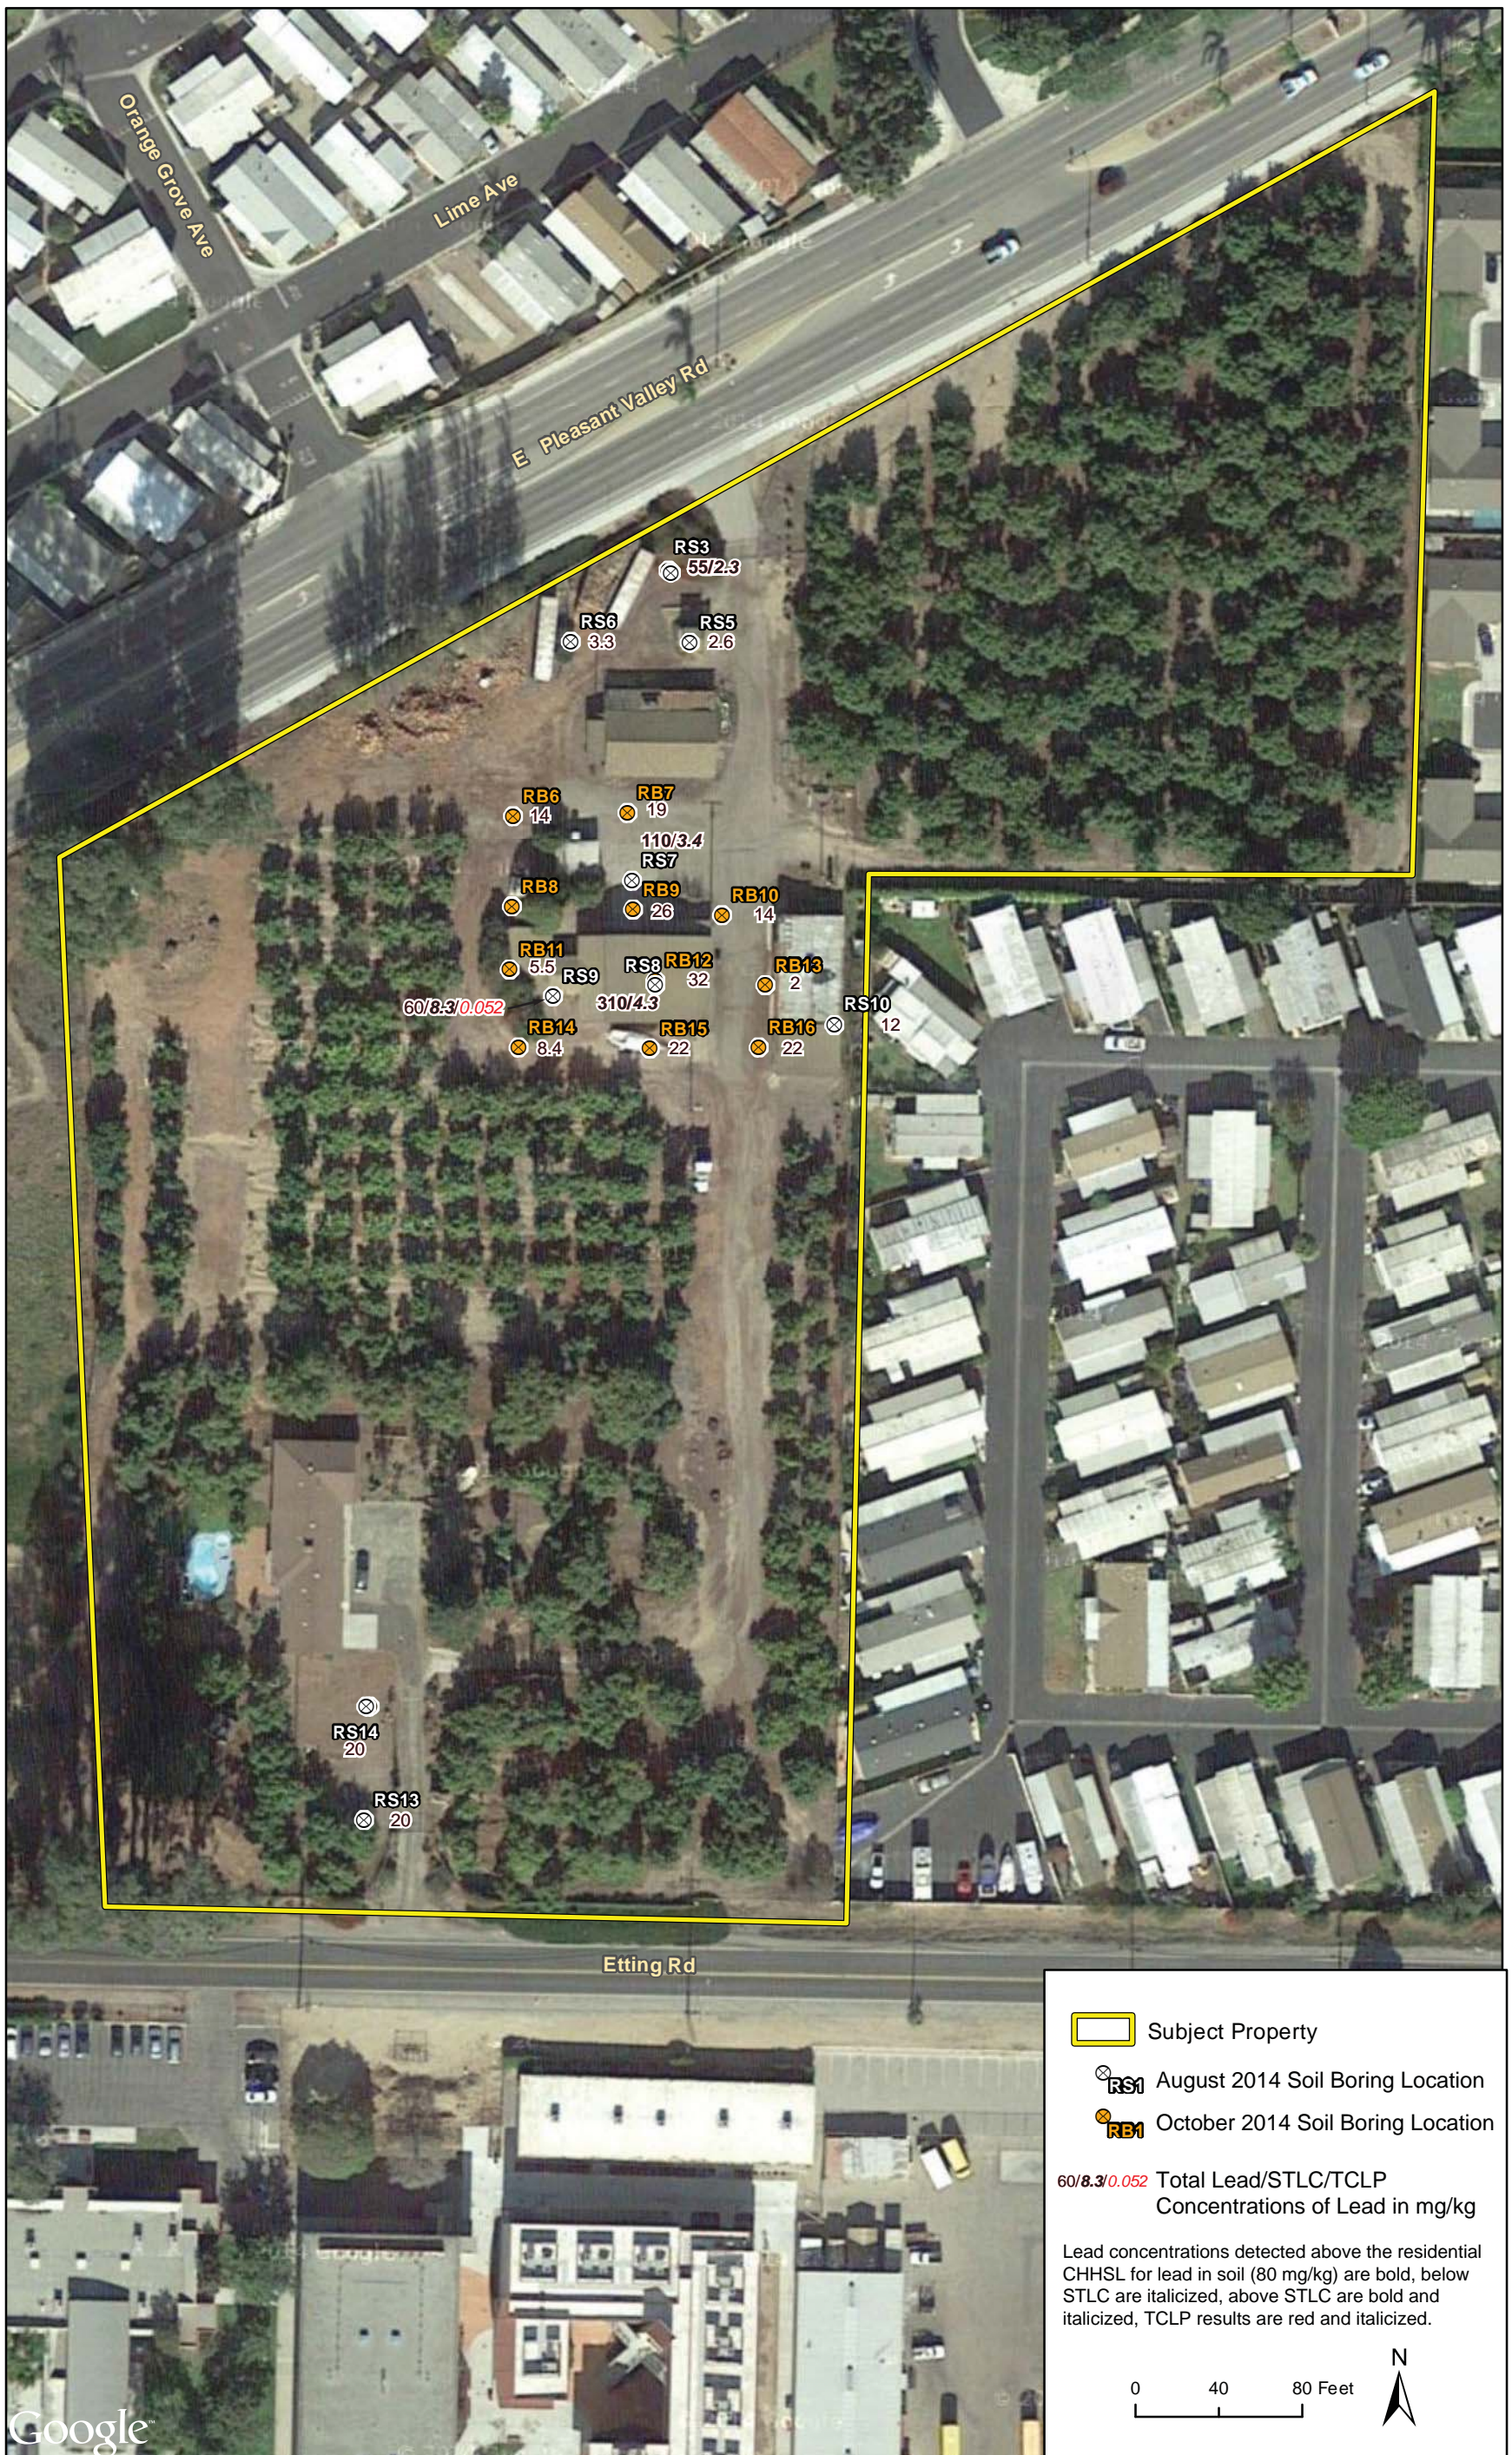
Figure 4

Lead Concentrations in Surface Soil Samples

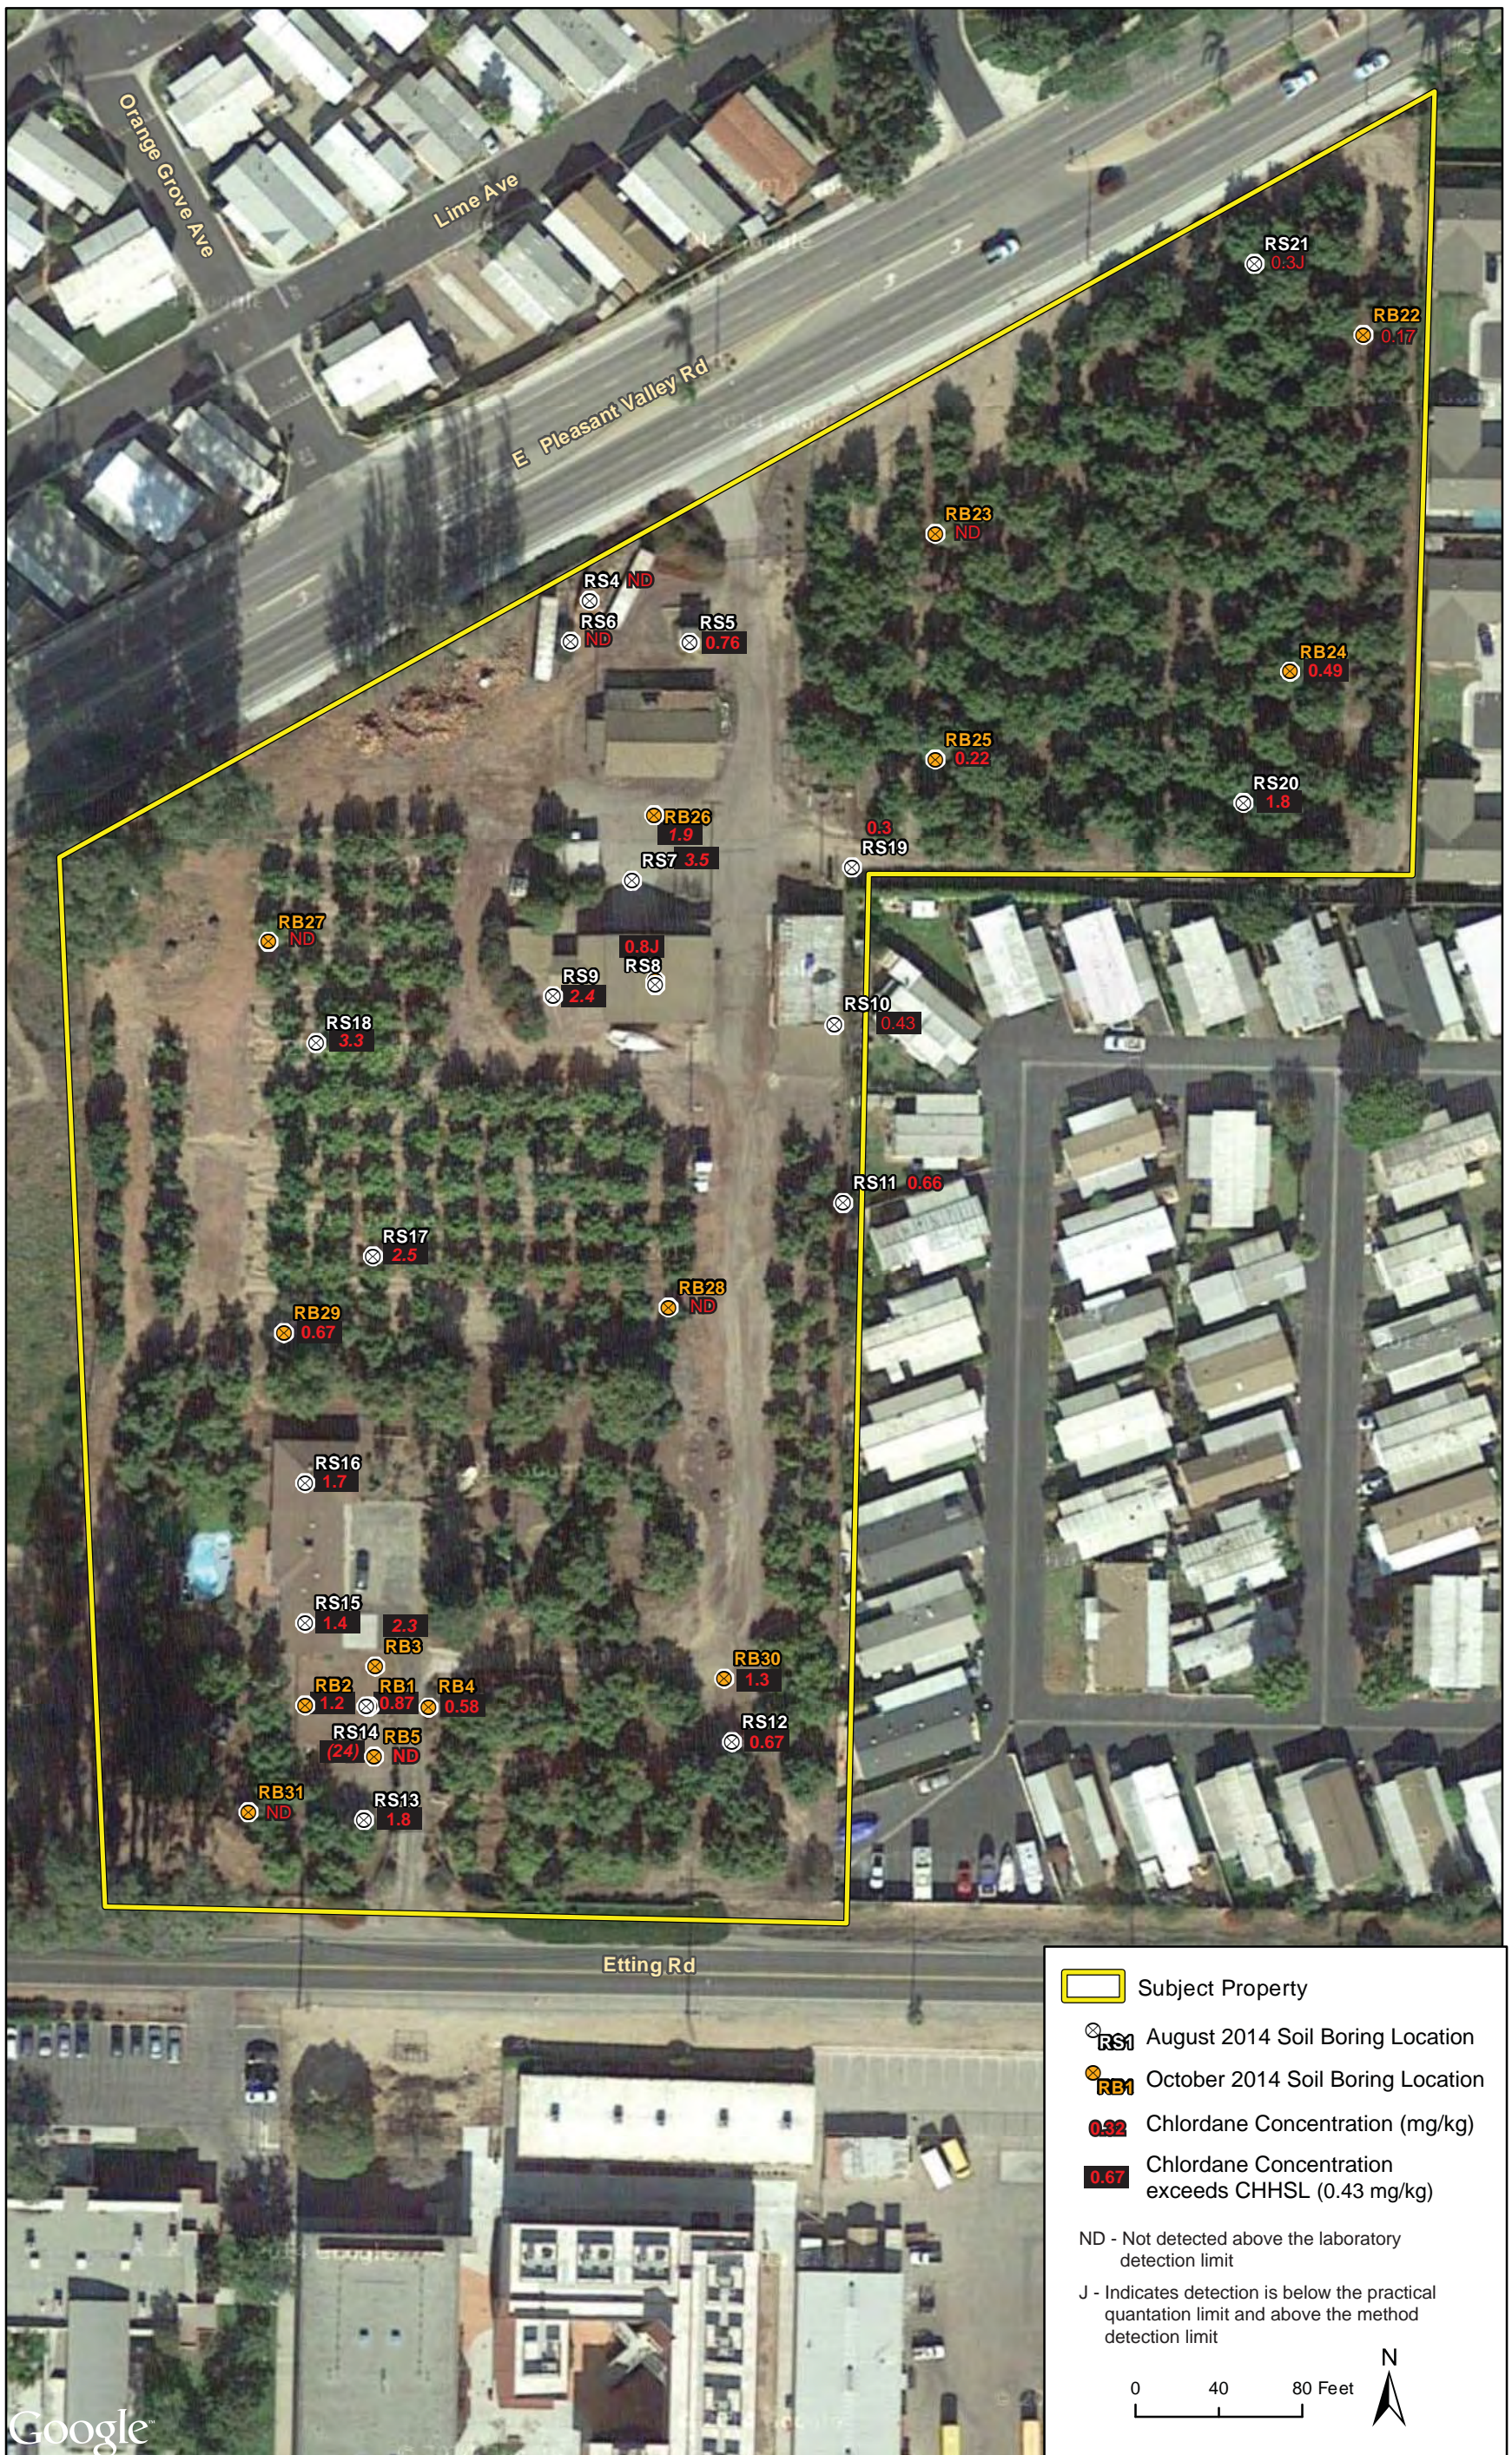
Figure 3

Chlordane Concentrations in Surface Samples

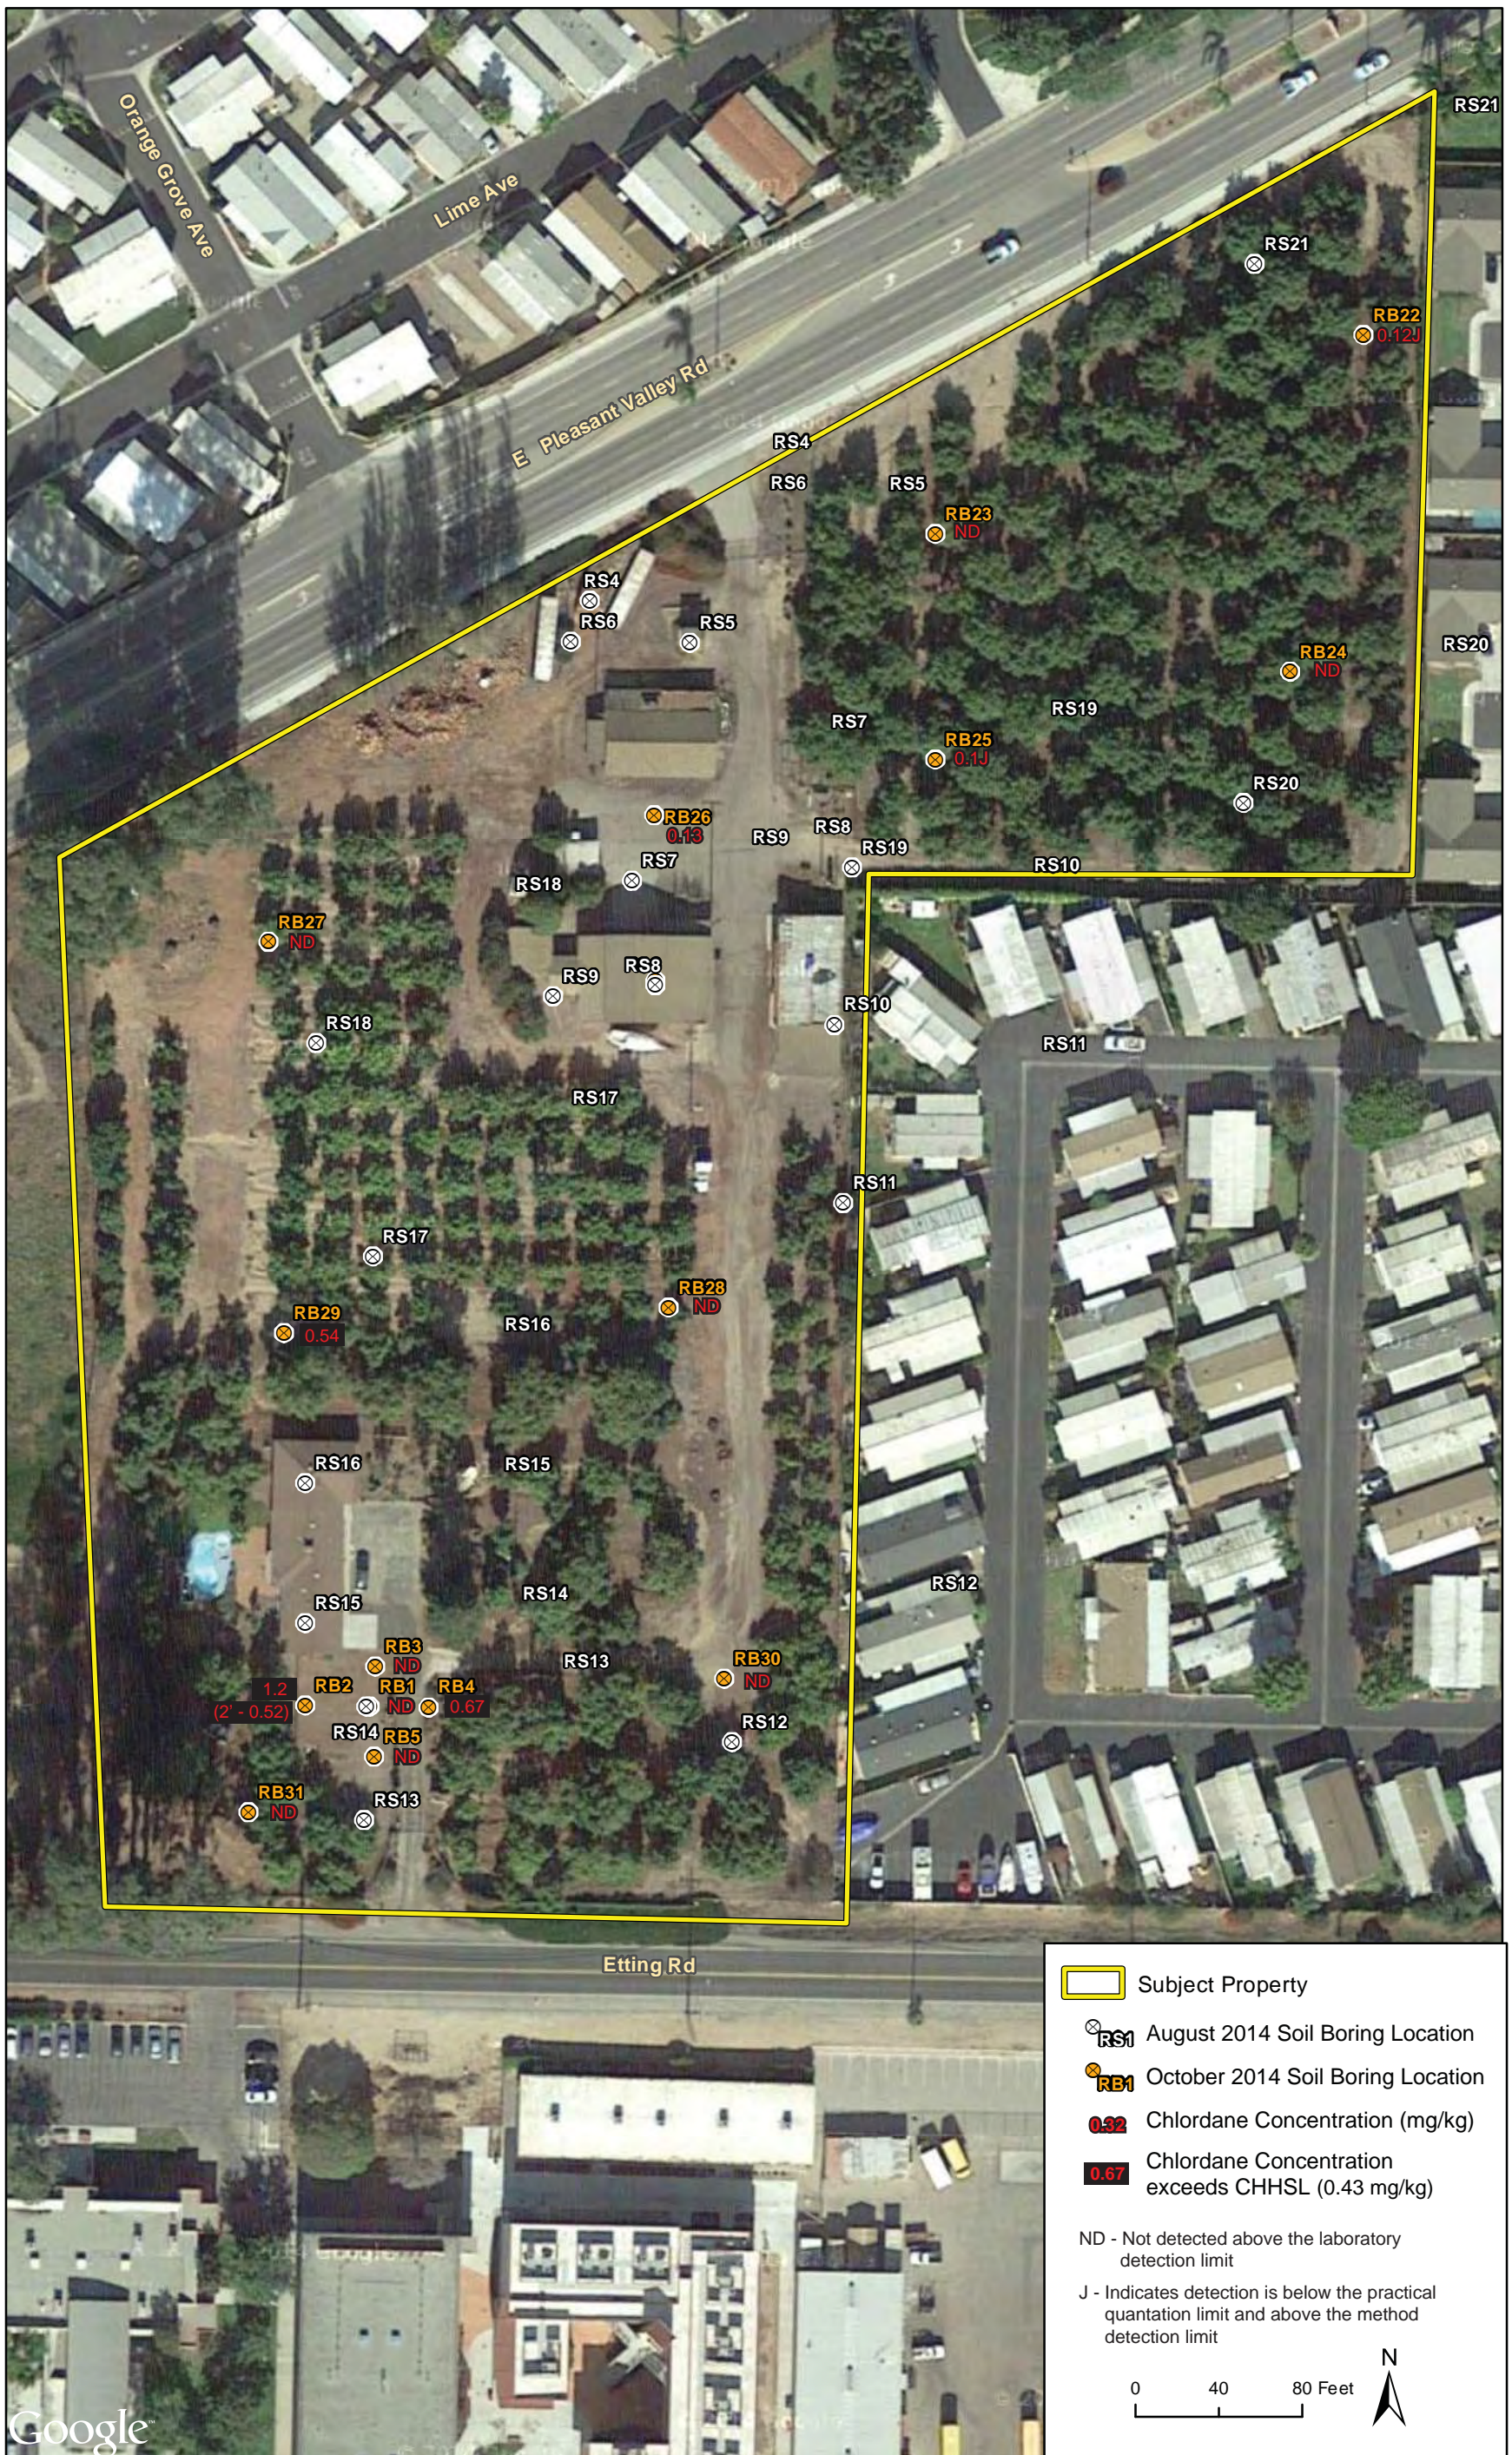
Figure 4

Chlordane Concentrations in Soil Samples 1 Foot Below Grade
