# **Coastal Apartment Homes Project and Coastal Senior / Assisted Living Project**

*Final*  
**Initial Study/  
Mitigated Negative  
Declaration**

**August 2015**

**Rincon Consultants, Inc.**  
180 Ashwood Ave.  
Ventura, California 93003

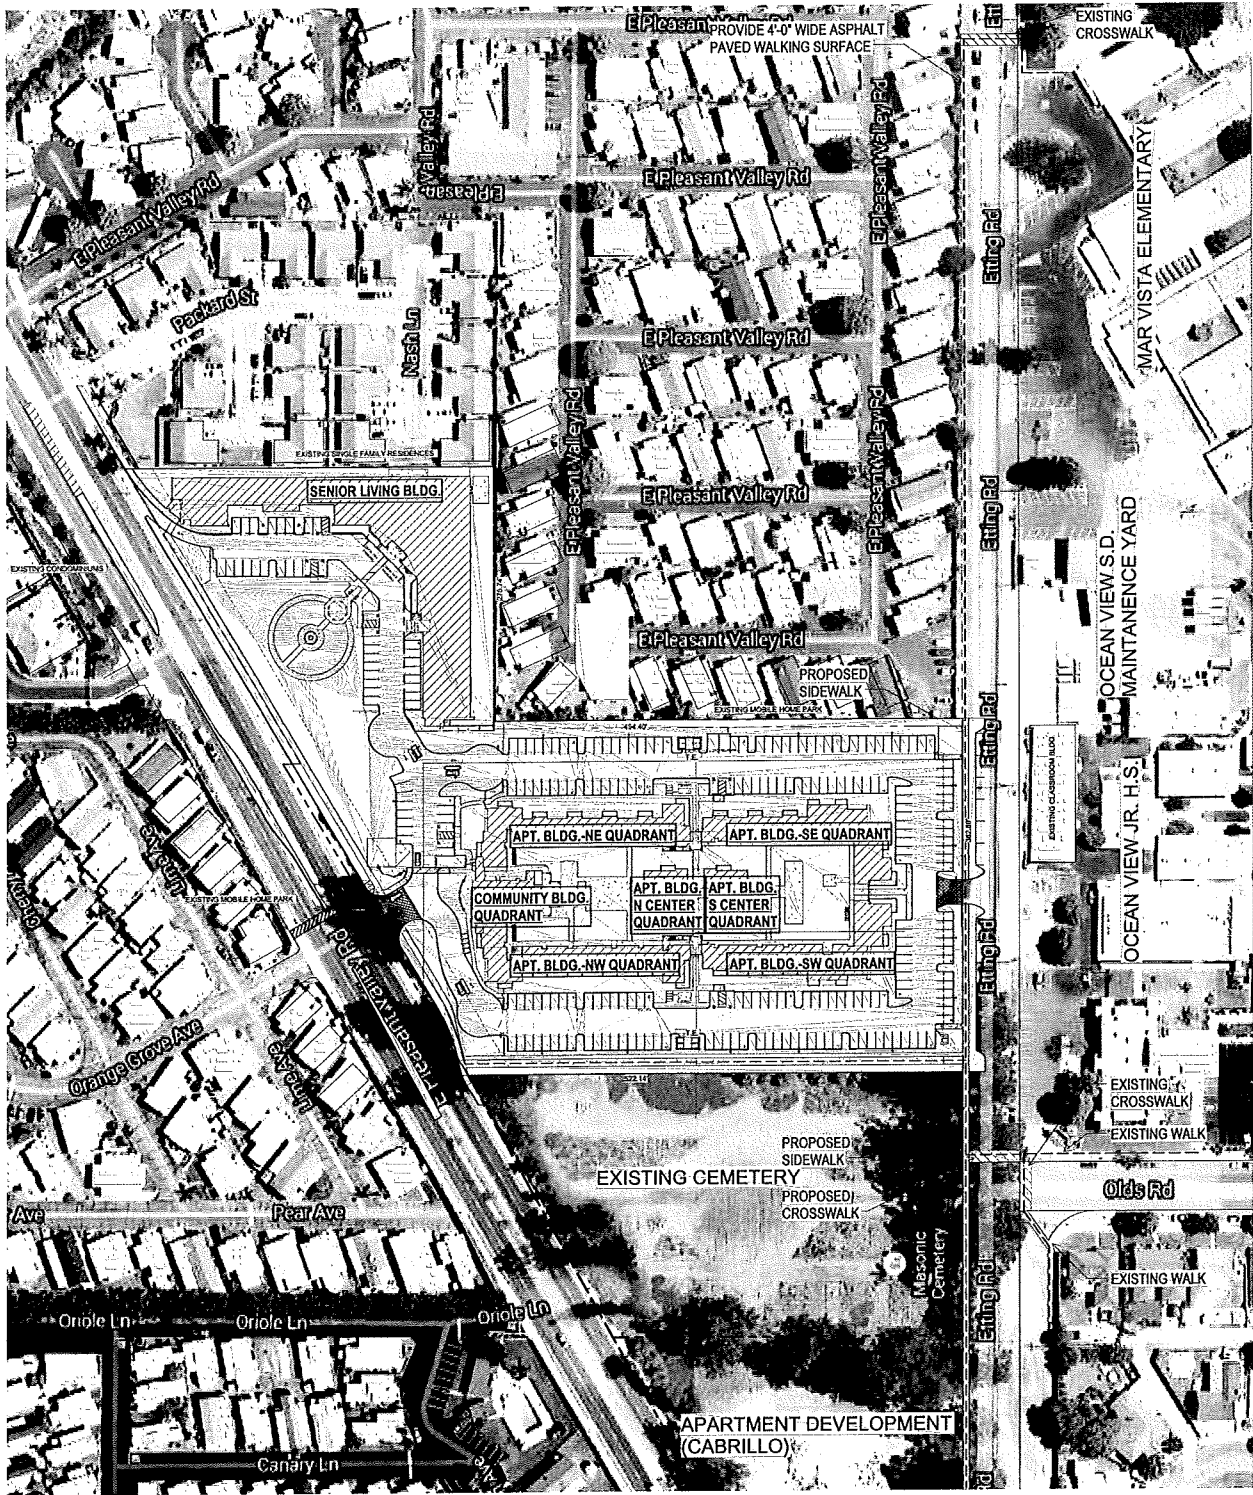
PROPOSED IMPROVEMENTS TO SAFE ROUTES TO SCHOOL

The pedestrian route to the two schools from the project site is to travel east-west along the north side of Etting Road and cross the street at the Olds Avenue intersection or at the mid-block crossing on Etting Road. It is recommended that a north-south pedestrian crosswalk be installed on the westbound approach of the Etting Road/Olds Avenue intersection in order to enhance the pedestrian route. The recommended route for children to walk to the school from the Naumann Ranch is illustrated on Figure 9.
